PAVEMENT CONDITION RATINGS

FOR THE NON-STATE
FEDERAL-AID ELIGIBLE
HIGHWAY SYSTEM
IN CHEMUNG COUNTY, NY

ELMIRA-CHEMUNG
TRANSPORTATION COUNCIL

2015

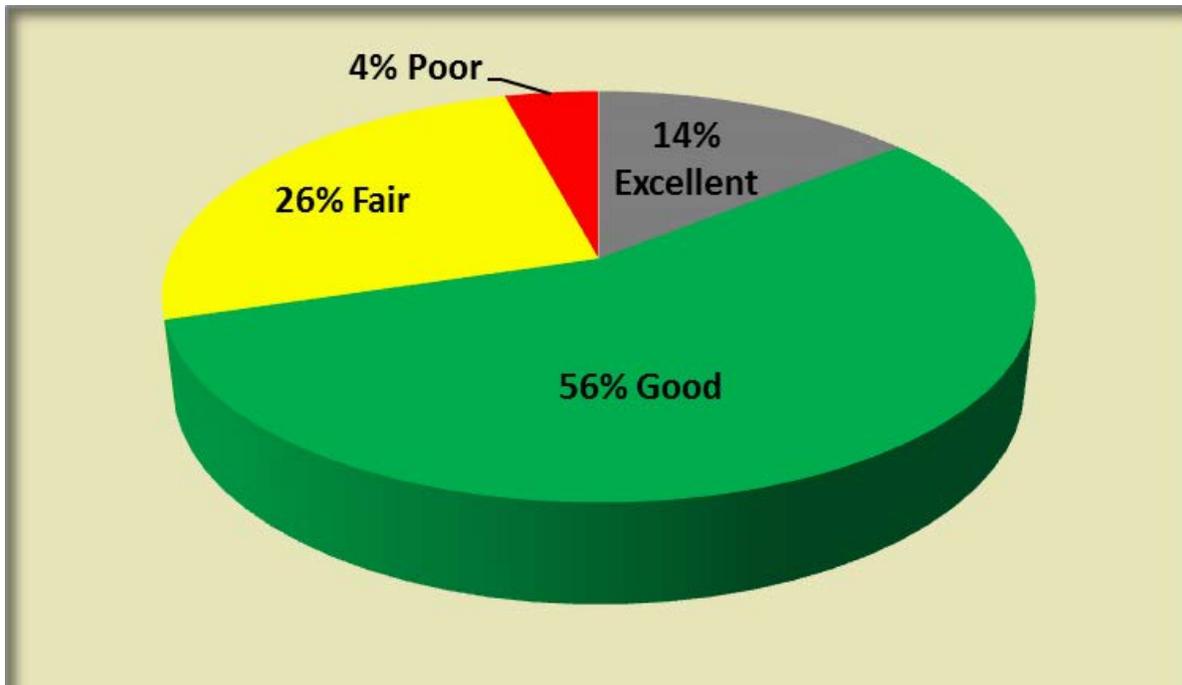
Chart 1

2015 All Non-State Federal Aid Eligible Road Surface Conditions

There were 141 miles of Non-State Federal-Aid Eligible roadways assessed and scored in Chemung County, NY in 2015. Of the 141 miles scored 85 miles belonged to Chemung County, 35 miles to the City of Elmira, and 21 miles belonged to the 7 other local municipalities. For the overall system, 14% of the roads were found to be in excellent condition, 56% in good condition, 26% in fair condition, and 4% in poor condition.

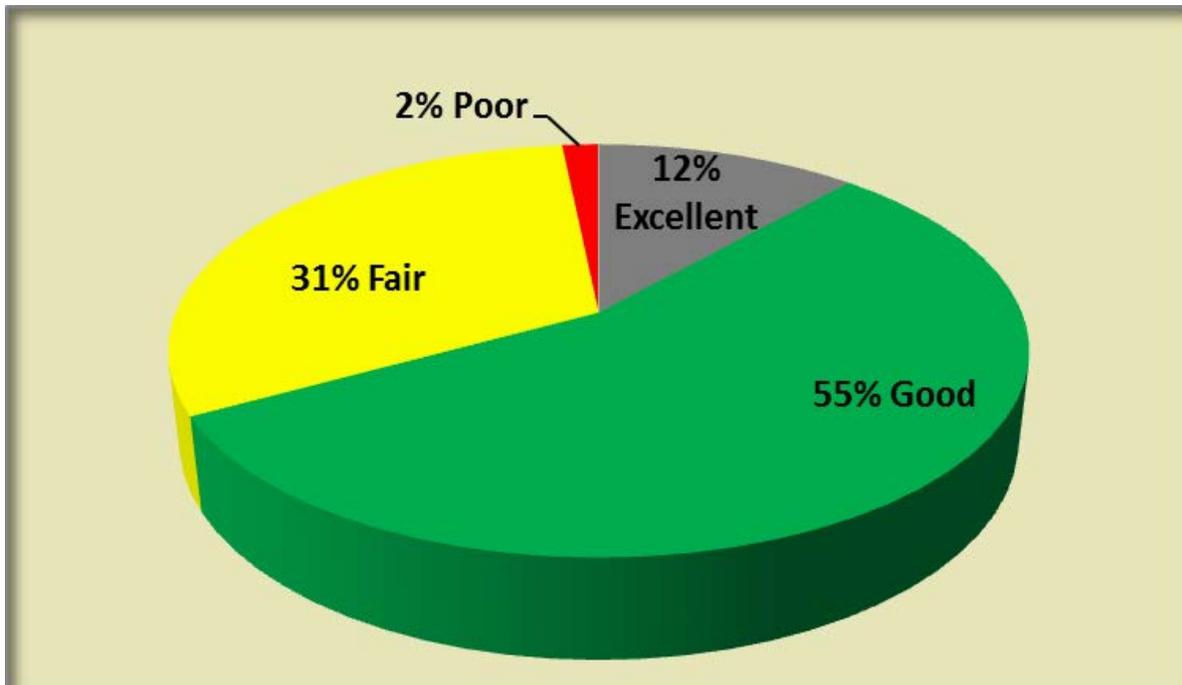
Chart 2

2015 Chemung County Federal Aid Eligible Road Surface Conditions

Chemung County Routes were found to have following pavement surface conditions; 10 miles or 12% excellent, 47 miles or 55% good, 27 miles or 31% fair, 1 mile or 2% poor.

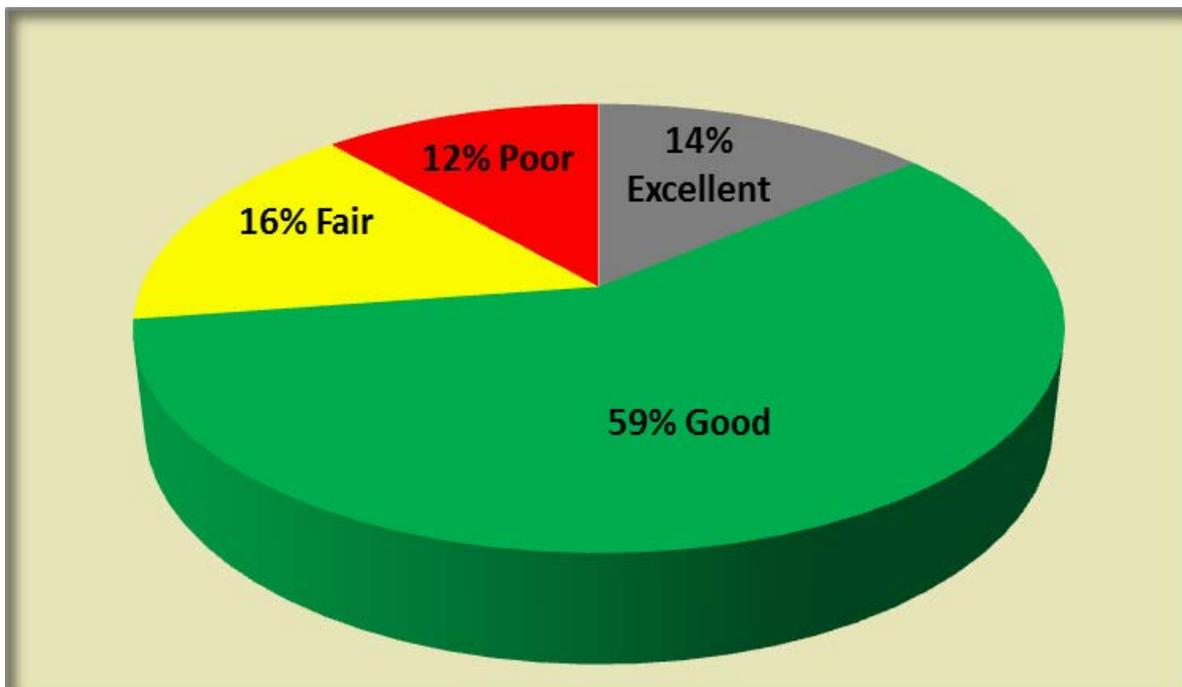
Chart 3

2015 City of Elmira Road Surface Conditions

City of Elmira streets were found to have the following surface conditions: 5 miles or 14% excellent, 21 miles or 59% good, 6 miles or 16% fair, 4 miles or 12% poor.

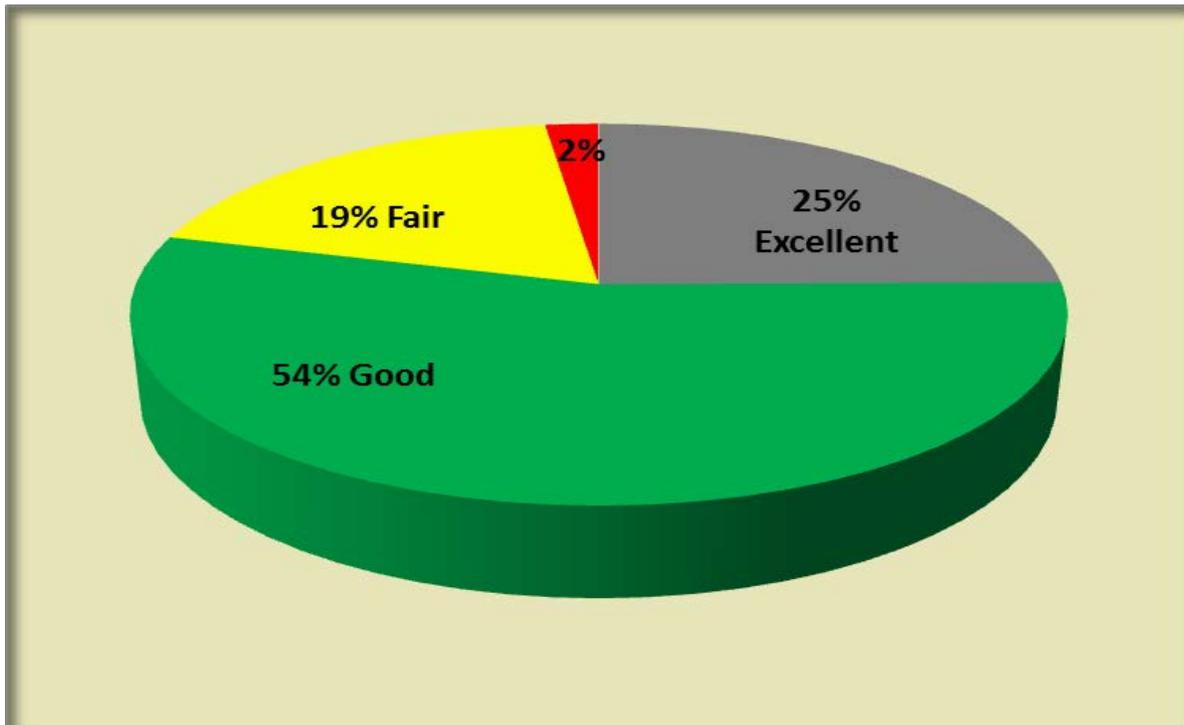
Chart 4

2015 Local Federal Aid Eligible Road Surface Conditions

The seven other locally owned roads had the following pavement surface conditions: 5 miles or 25% excellent, 11 or 54% good, 4 miles or 19% fair, >1 mile or 2% poor.

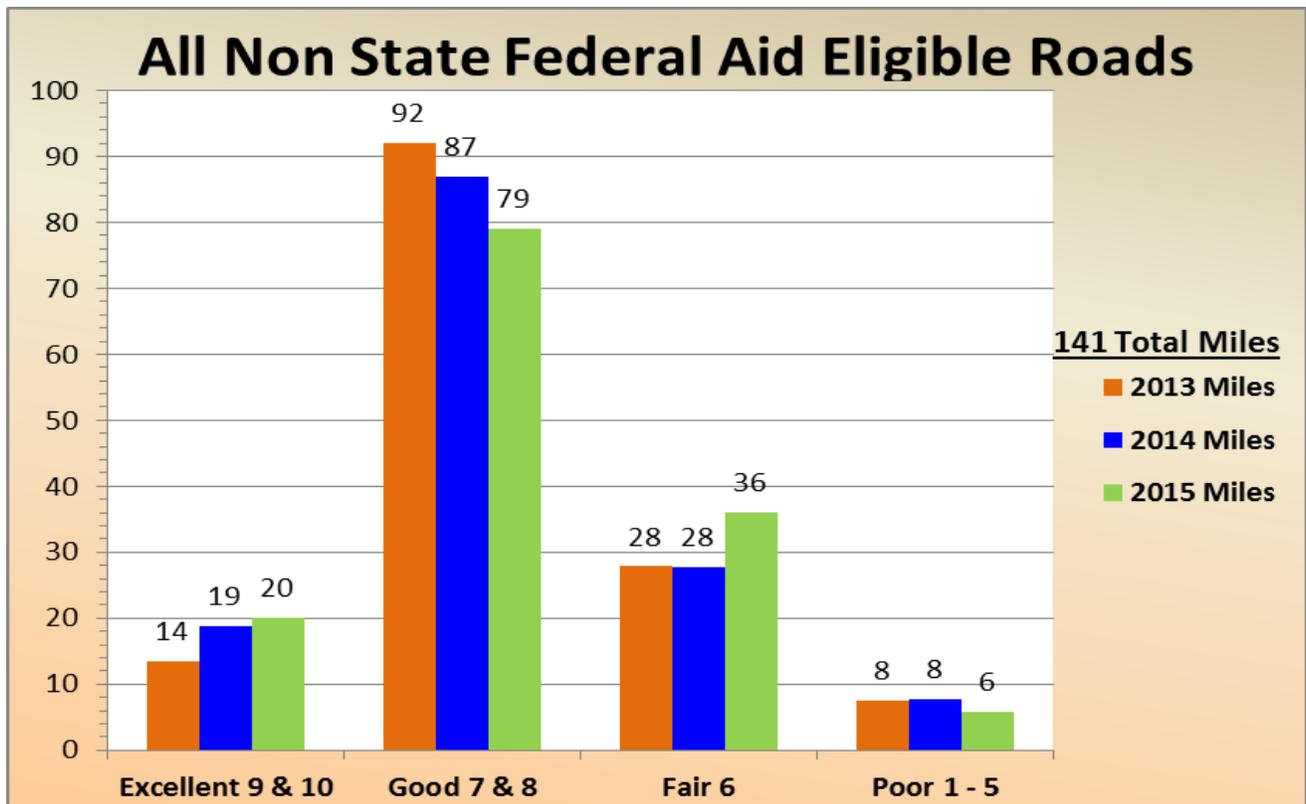
Chart 5 provides a comparison all 141 miles of Non-State Federal-Aid Eligible Highways from 2013 through 2015. In 2013 there were 14 miles of roads which received an ‘Excellent’ rating. This number increased 4%, or 5 miles to 19 miles from 2013 to 2014 and an additional 1 mile from 2014 to 2015 to 20 total miles. The number of roads rated as ‘Good’ in 2013 was 92 miles. The number of good miles decreased in 2014 by 4% or 5 miles to 87 miles and decreased again in 2015 by 5% or 8 miles to 79 miles. The number of roads rated as ‘Fair’ was 28 miles in 2013 and stayed at the level through 2014 and increased 6%, up 8 miles from 2014 to 2015. The number of roads rated ‘Poor’ was 8 miles in 2013 and 2014 and decreased 1% to 6 miles in 2015.

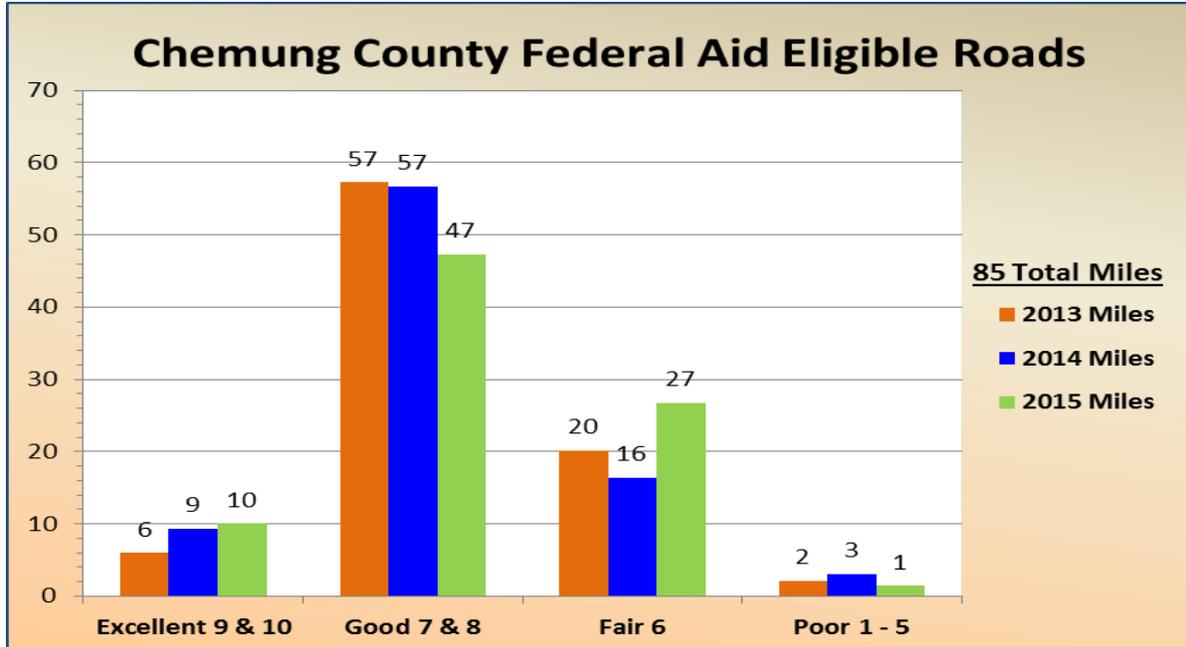
In Chart 6 is a breakdown of the miles by rating for the County owned Federal Aid Eligible roads in Chemung County.

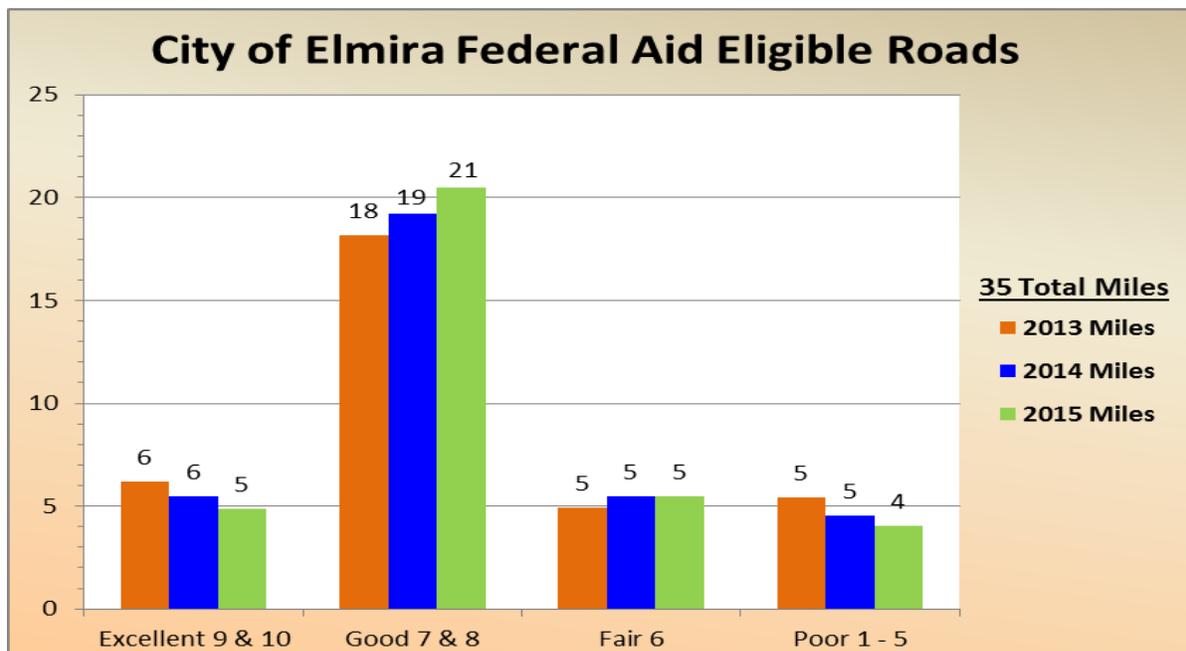
Chart 7 is a breakdown of the miles by rating for the City of Elmira owned Federal Aid Eligible roads.

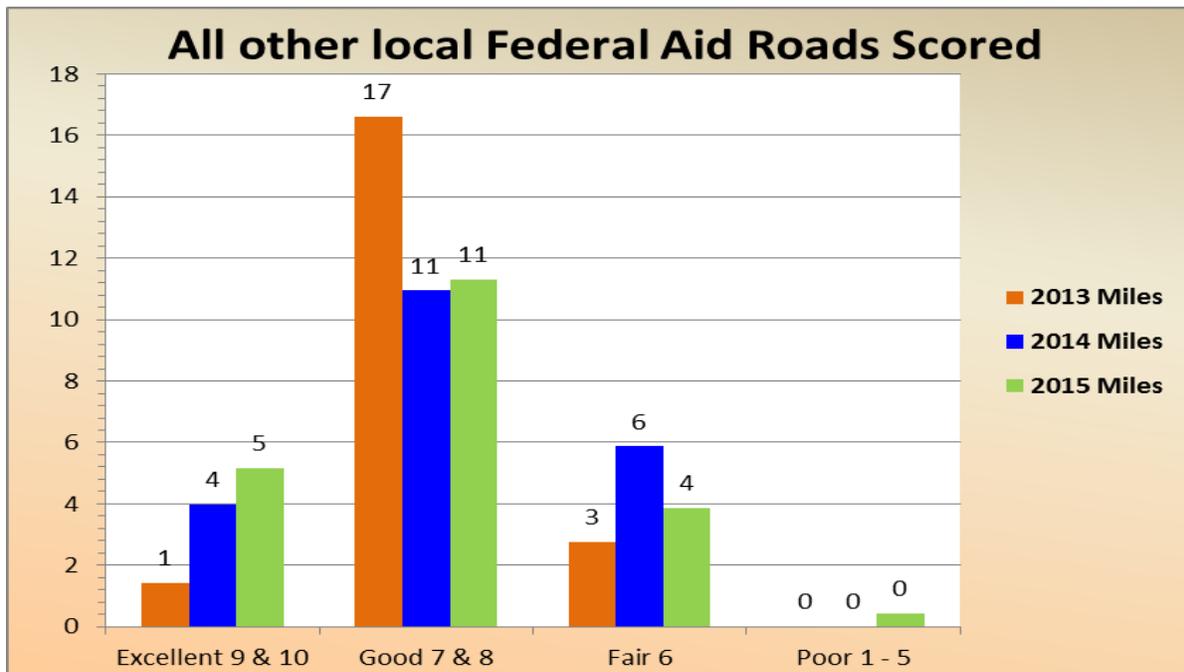
Chart 8 is a breakdown of miles by rating for remaining 21 miles of locally owned Federal Aid Eligible roads in Chemung County.

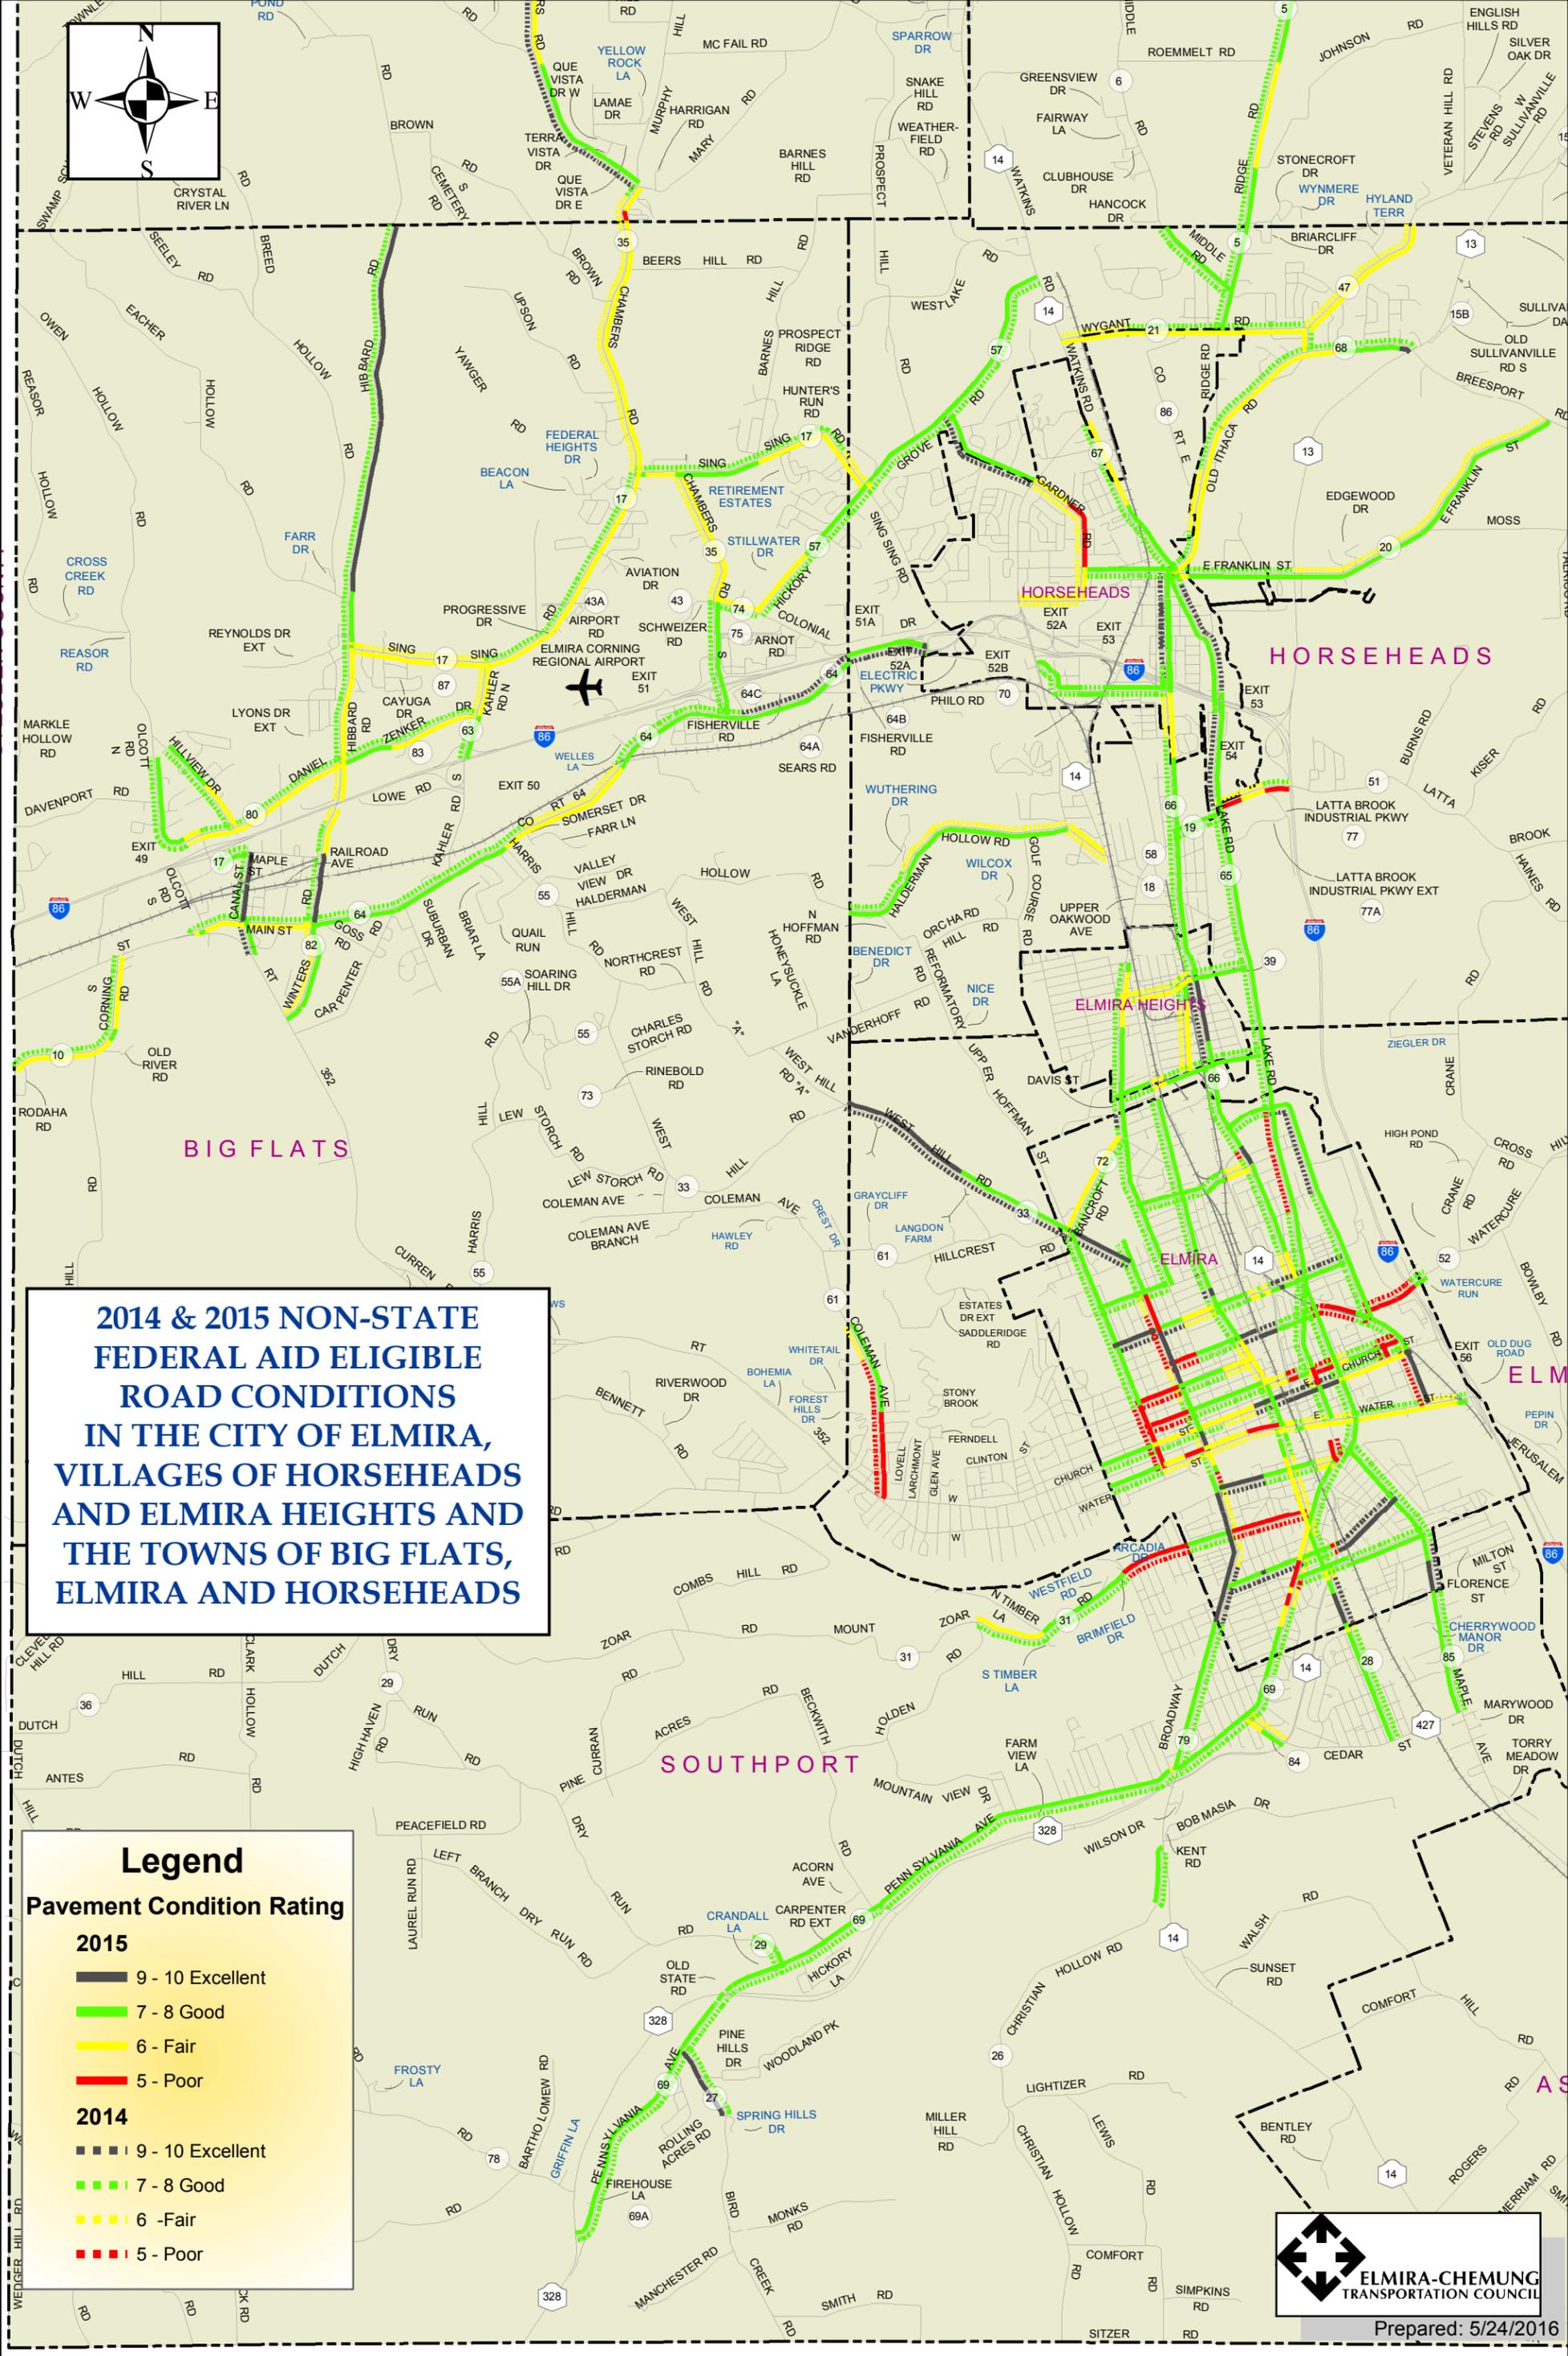
**2014 & 2015 NON-STATE
FEDERAL AID ELIGIBLE
ROAD CONDITIONS
IN THE CITY OF ELMIRA,
VILLAGES OF HORSEHEADS
AND ELMIRA HEIGHTS AND
THE TOWNS OF BIG FLATS,
ELMIRA AND HORSEHEADS**

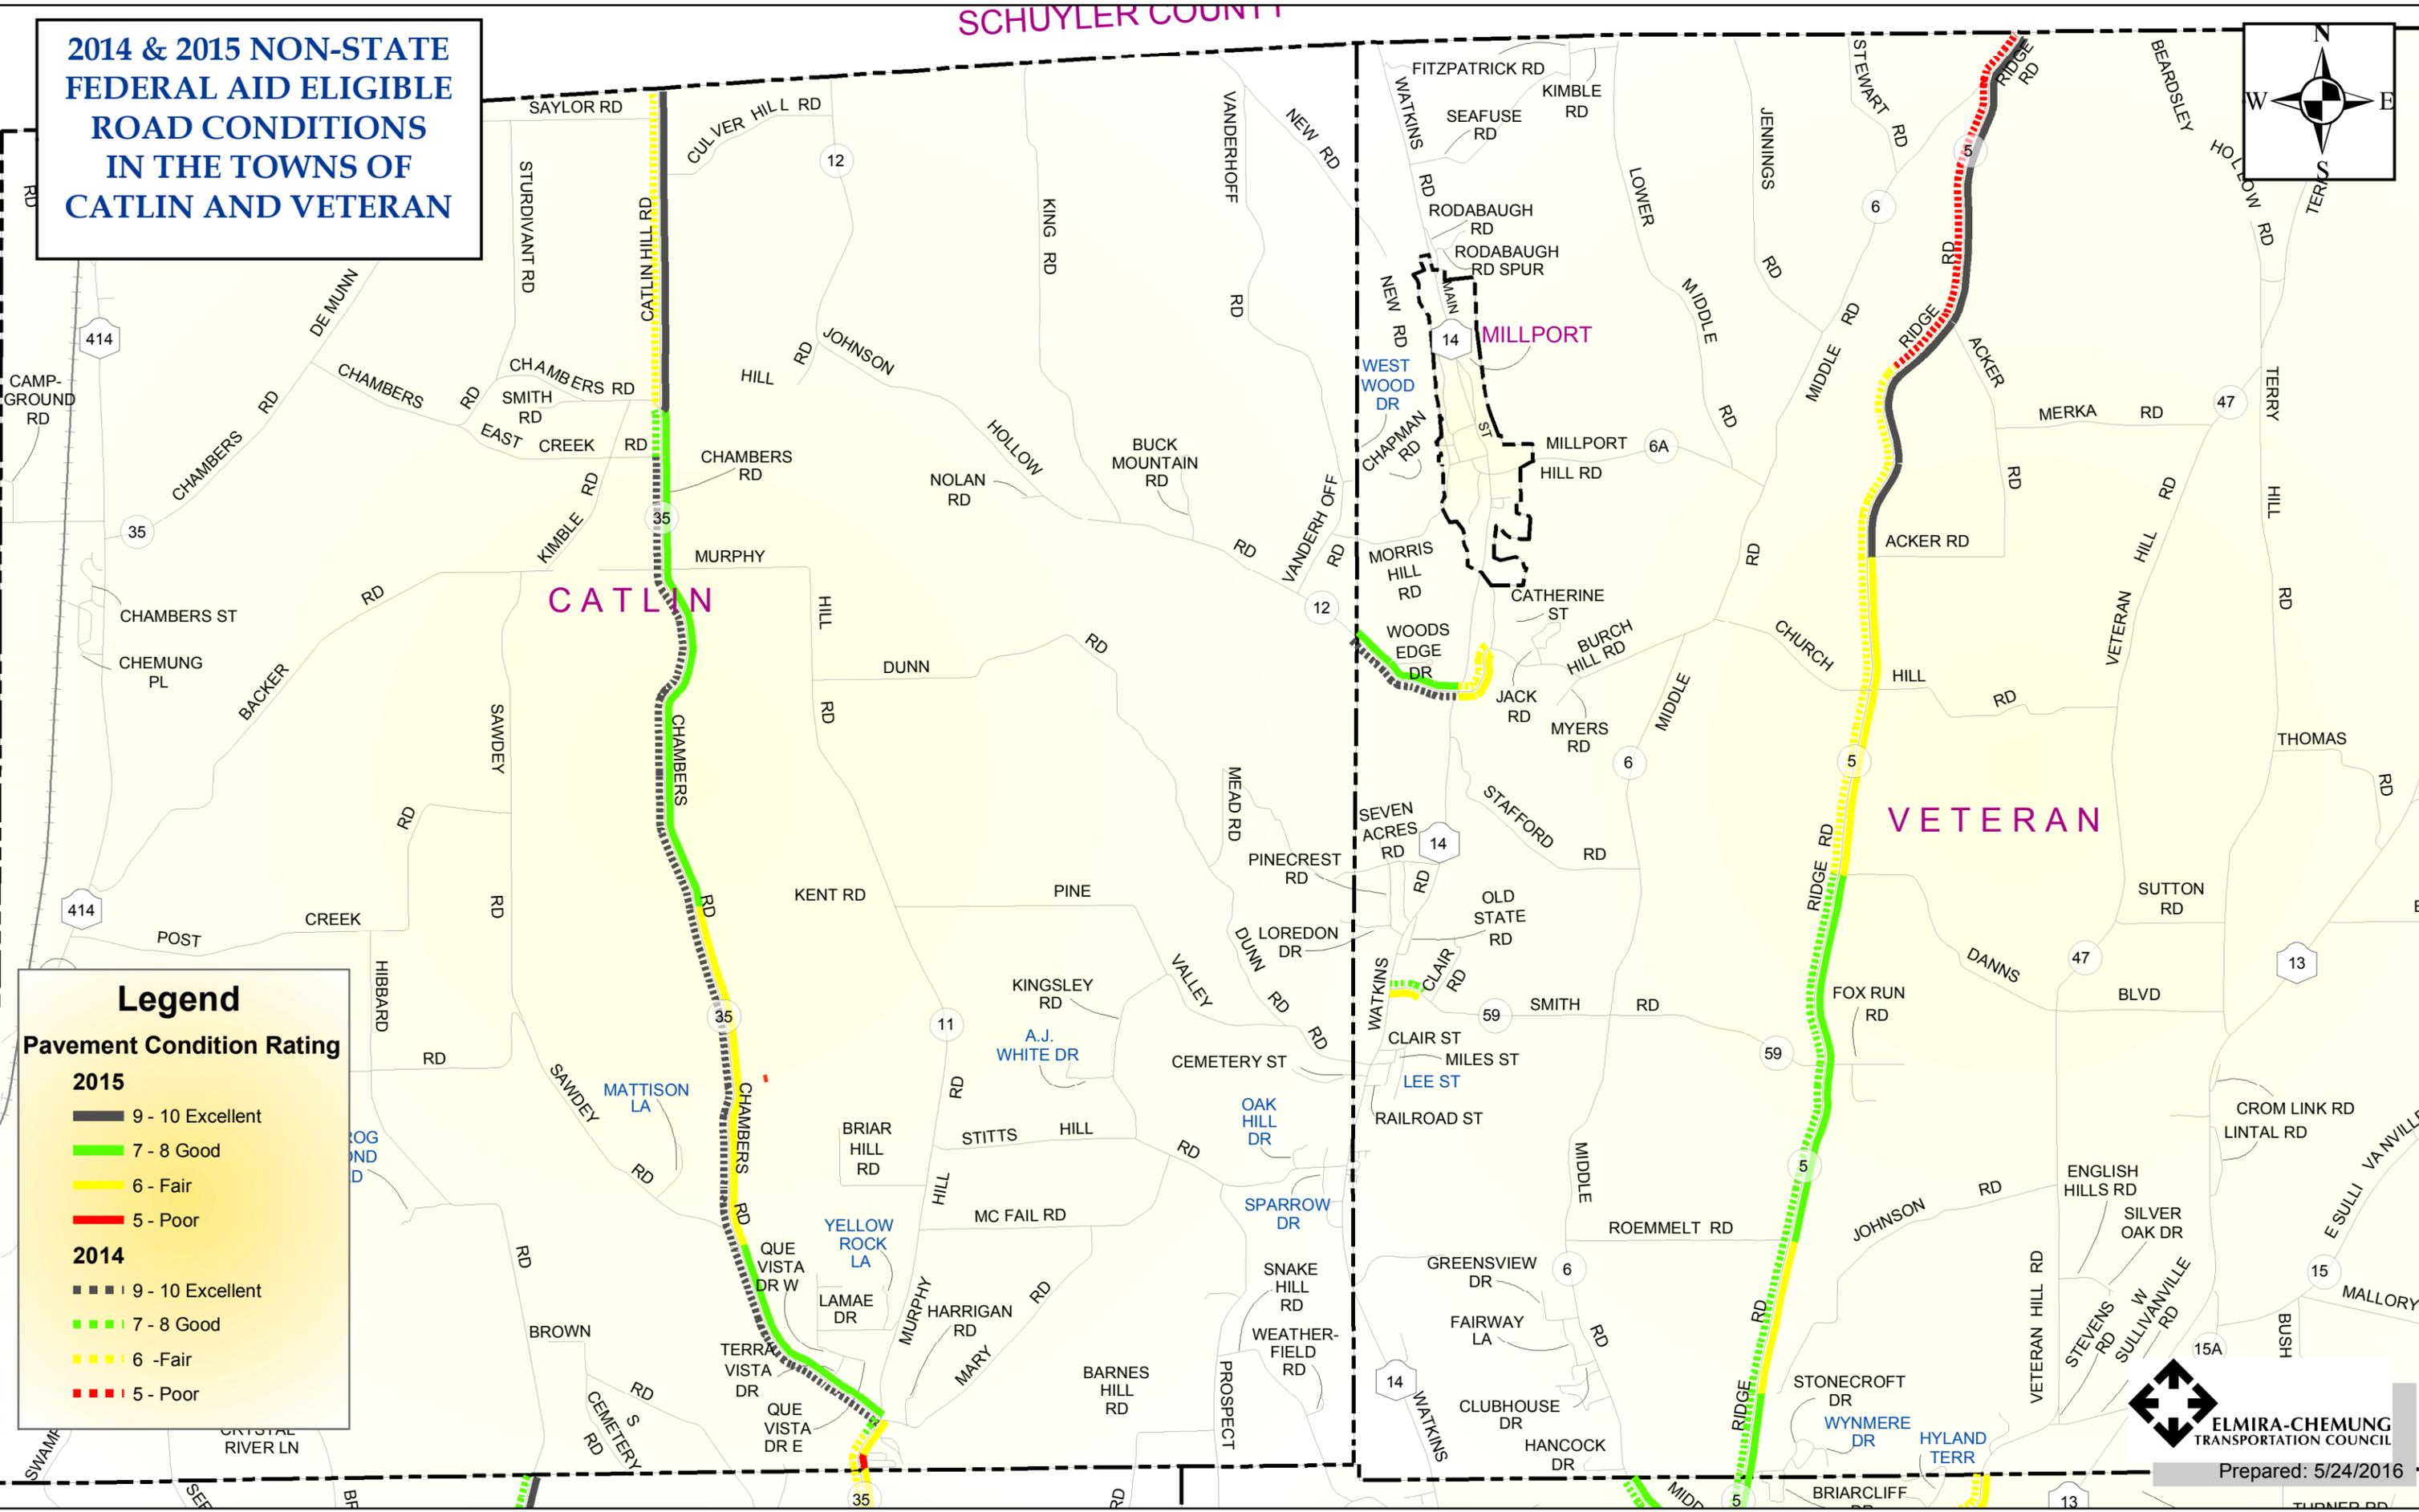
2014 & 2015 NON-STATE FEDERAL AID ELIGIBLE ROAD CONDITIONS IN THE TOWNS OF CATLIN AND VETERAN

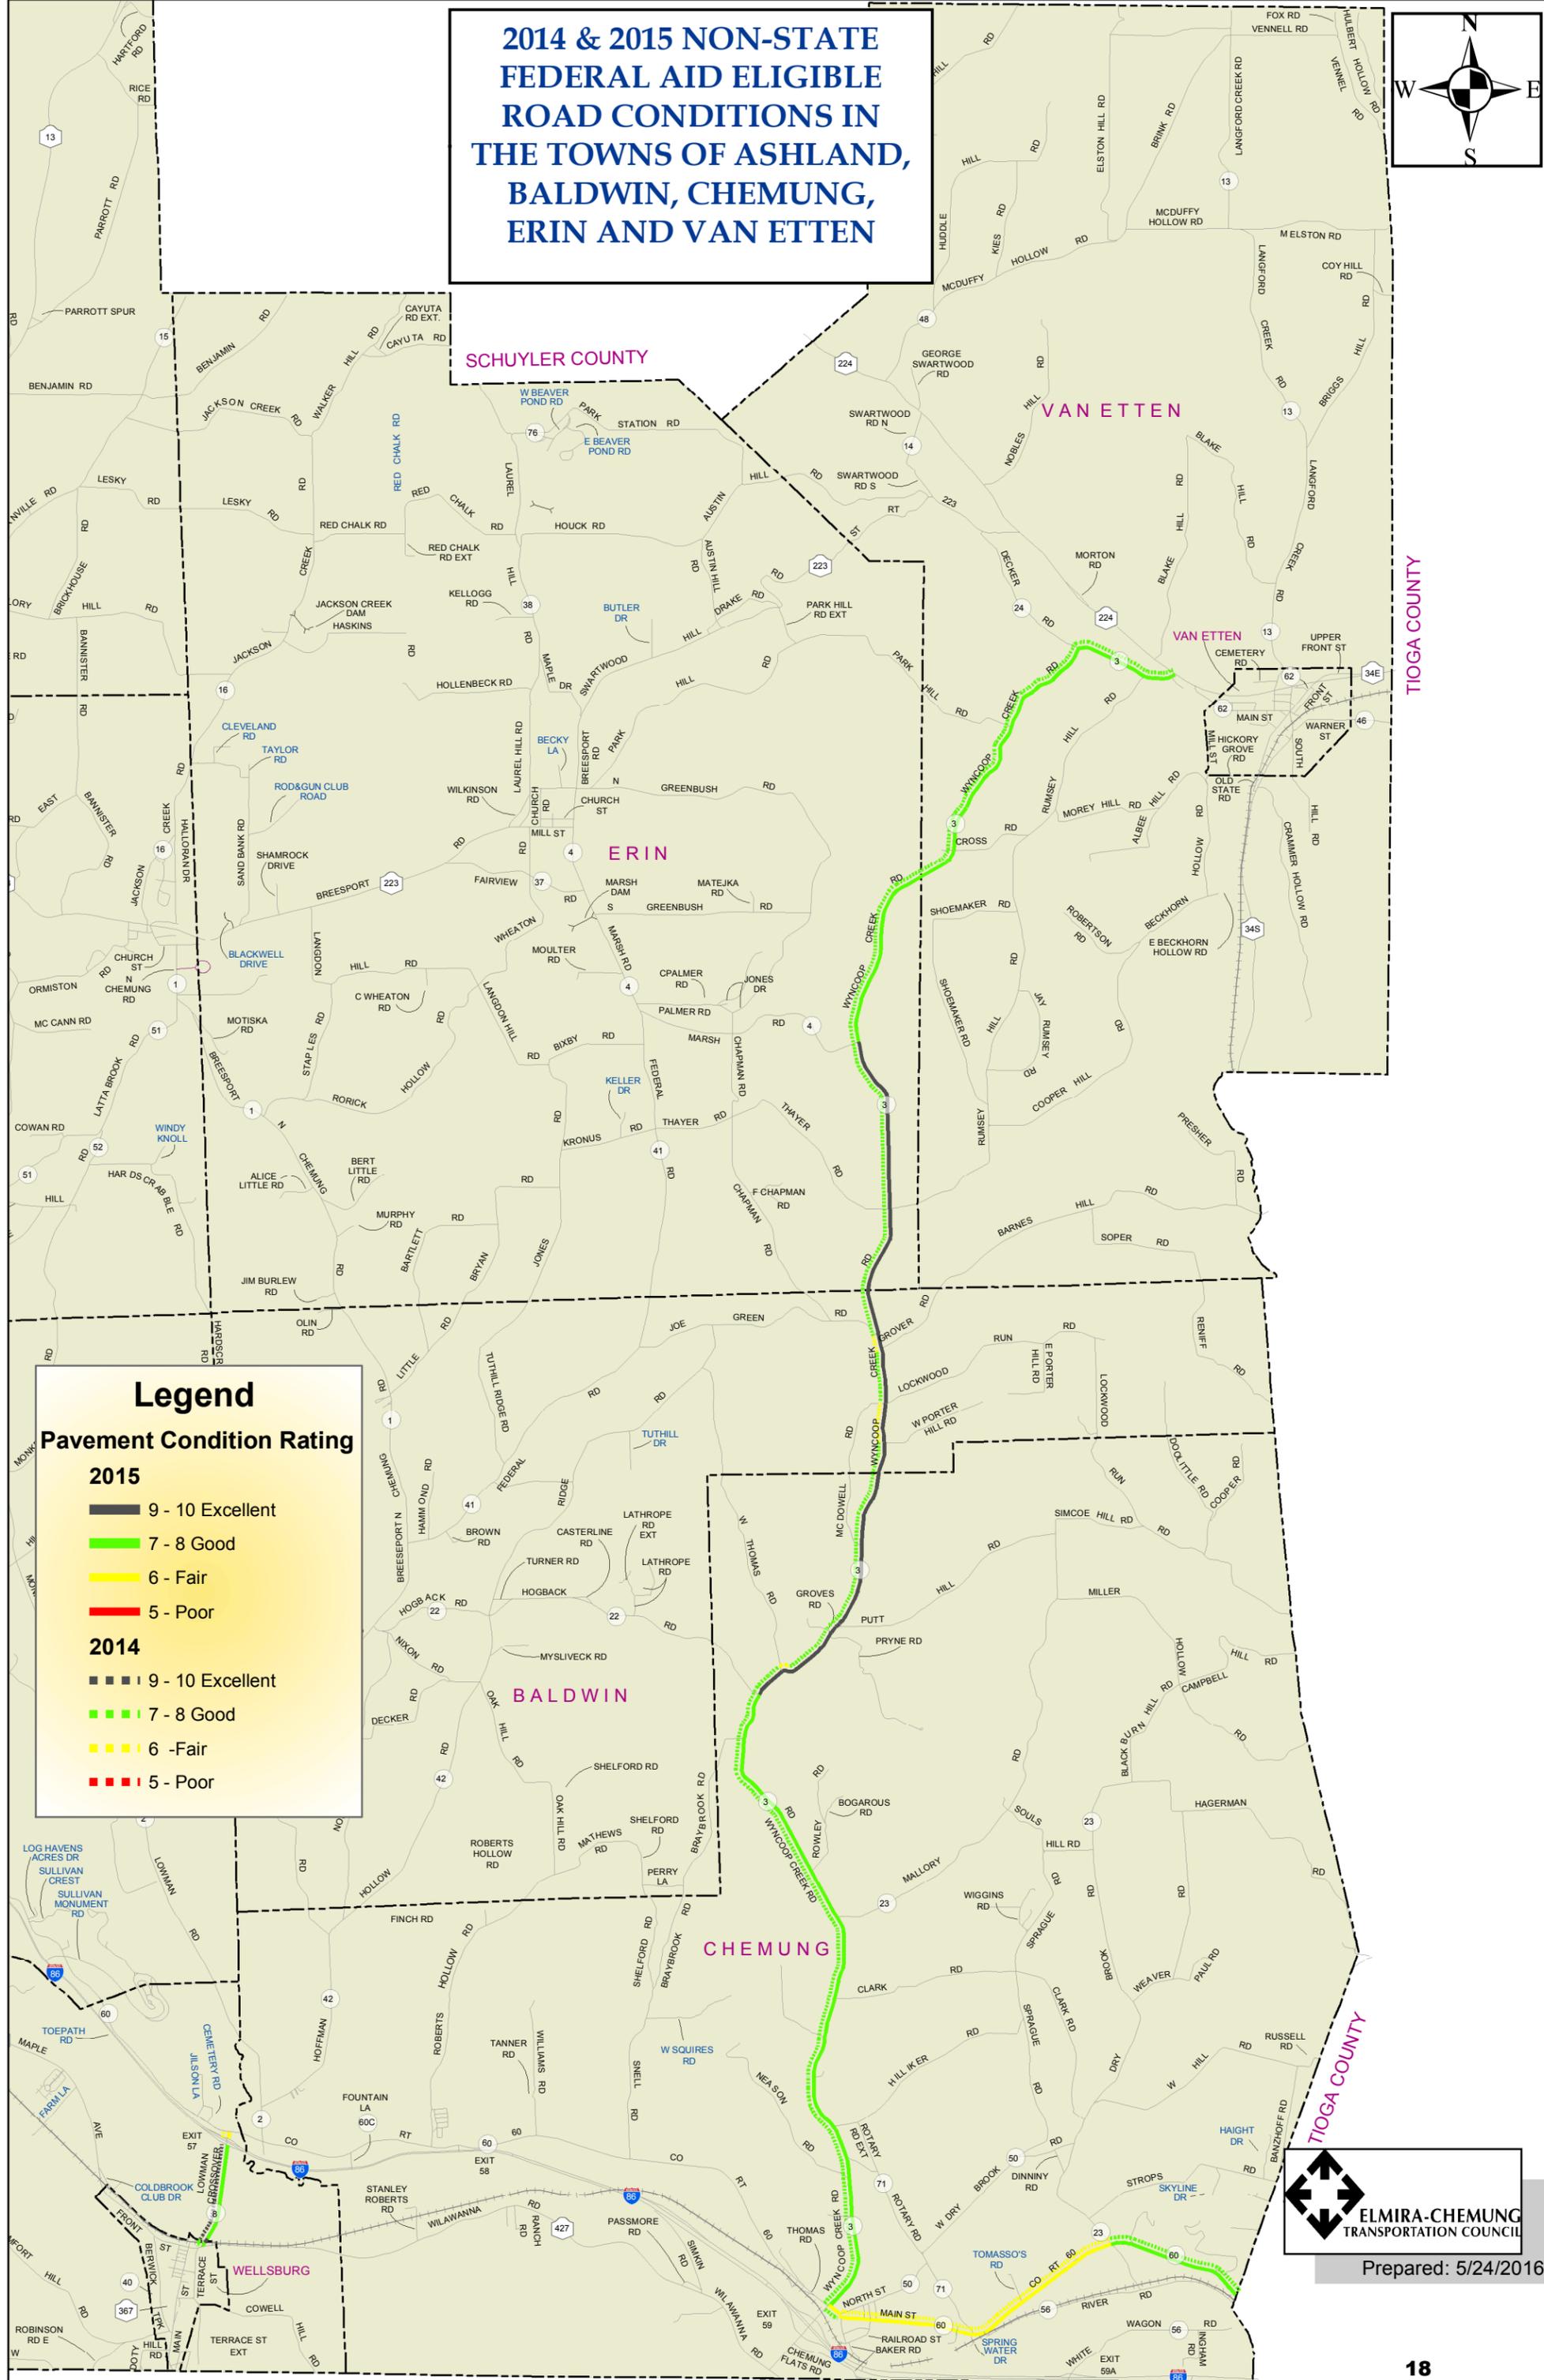
2014 & 2015 NON-STATE FEDERAL AID ELIGIBLE ROAD CONDITIONS IN THE TOWNS OF ASHLAND, BALDWIN, CHEMUNG, ERIN AND VAN ETTEN

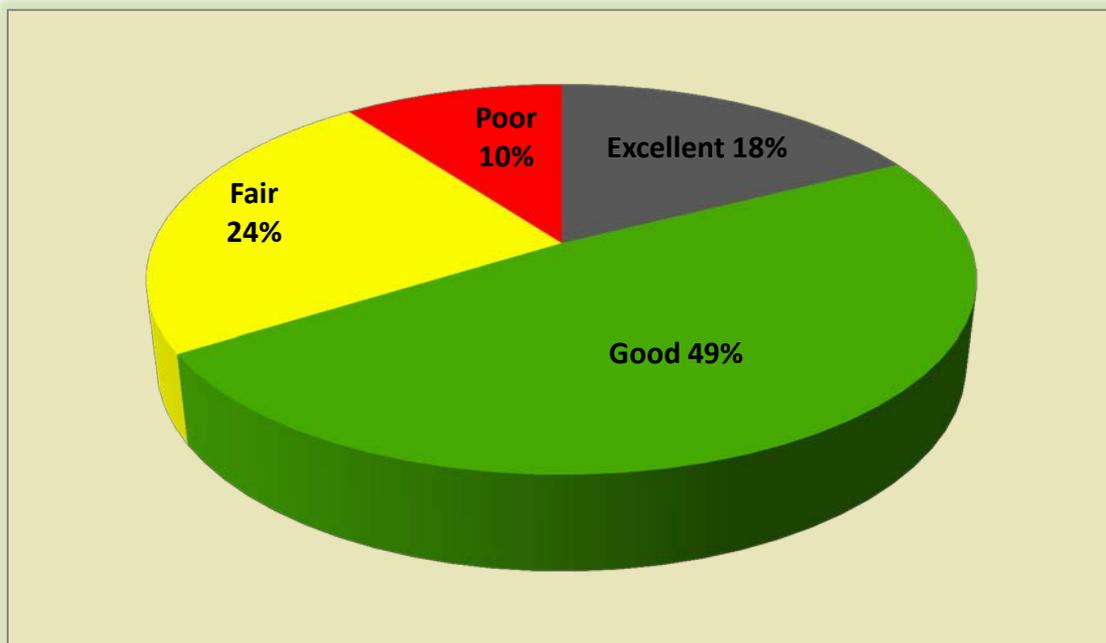
Chart 1

2015 Chemung County Road Surface Conditions

The Chemung County pavement conditions were as follows: 43 miles or 18% excellent, 119 miles or 49% good, 58 or 24% fair and 25 miles or 10% poor.

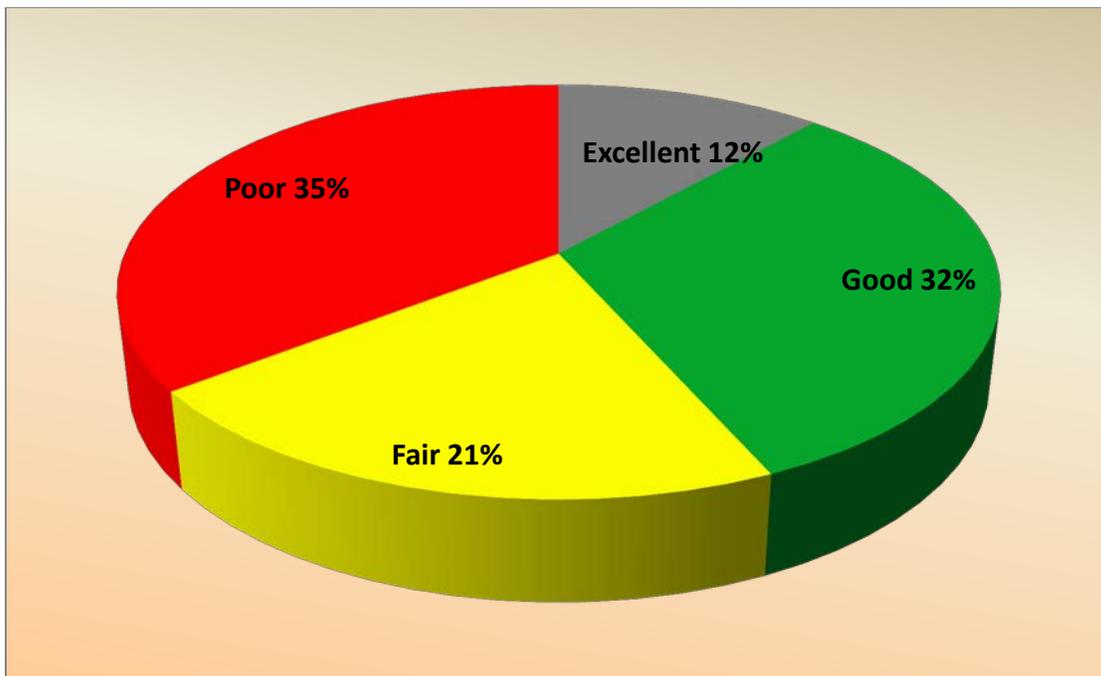
Chart 2

2015 City of Elmira Road Surface Conditions

The City of Elmira pavement conditions were as follows: 14 miles or 12% excellent, 38 miles or 32% good, 25 miles or 21% fair and 42 miles or 35% poor.

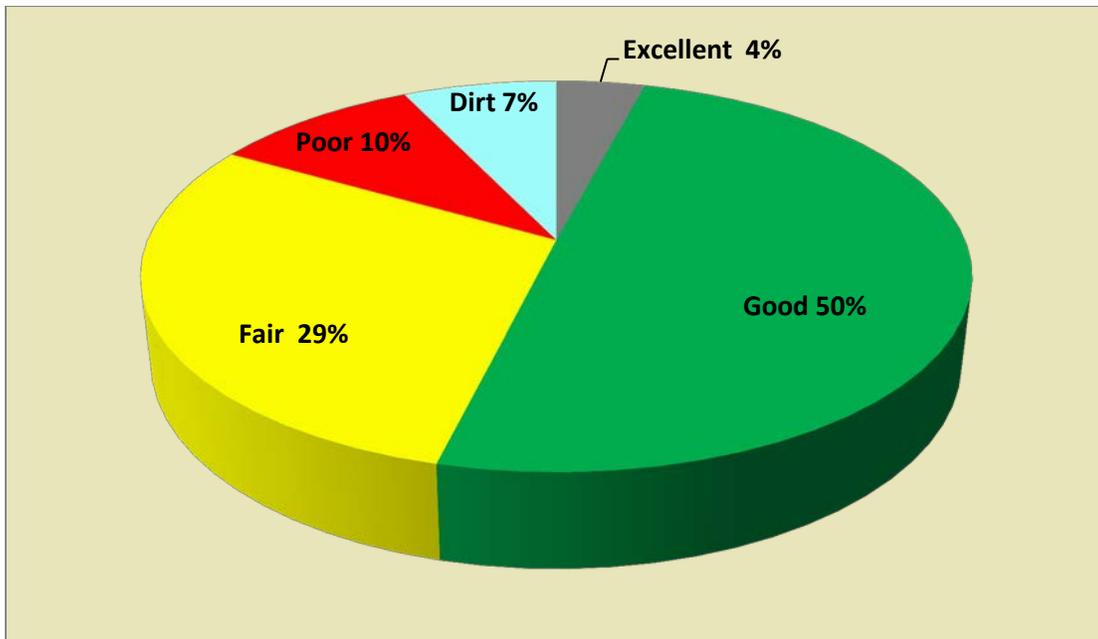
Chart 3

2015 Town of Elmira Road Surface Conditions

The Town of Elmira conditions were as follows: 2 miles or 4% excellent, 23 miles or 50% good, 13 or 29% fair, 4 miles or 10% poor,

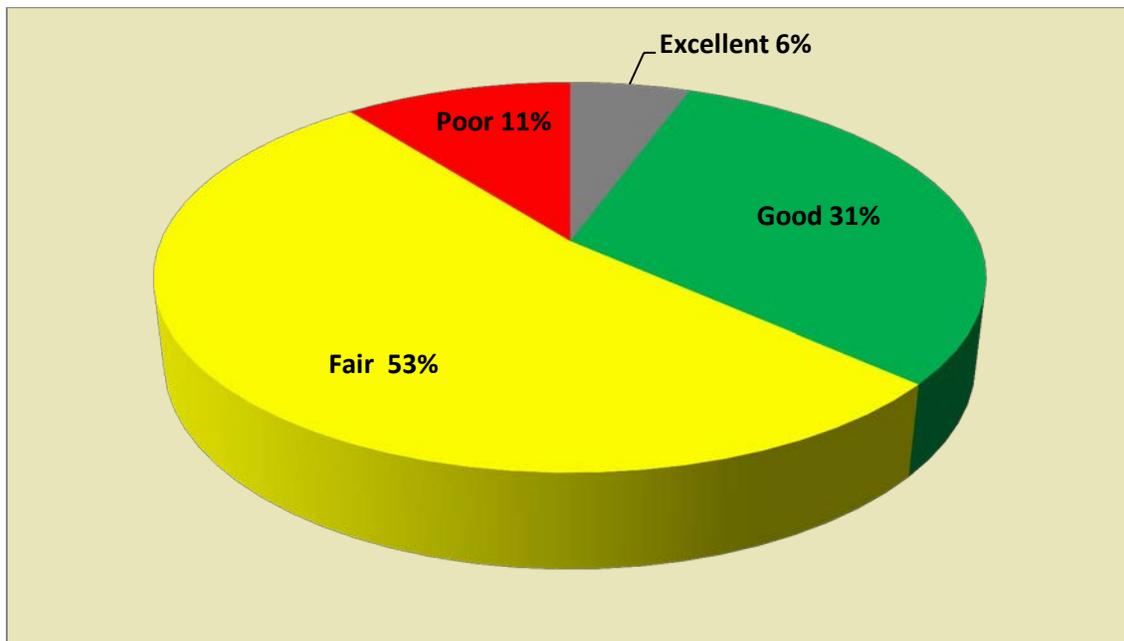
Chart 4

2015 Village of Elmira Heights Road Surface Conditions

The Village of Elmira Heights conditions were as follows: 1 mile or 6% excellent, 6 miles or 31% good, 101 or 53% fair and 2 miles or 11% poor.

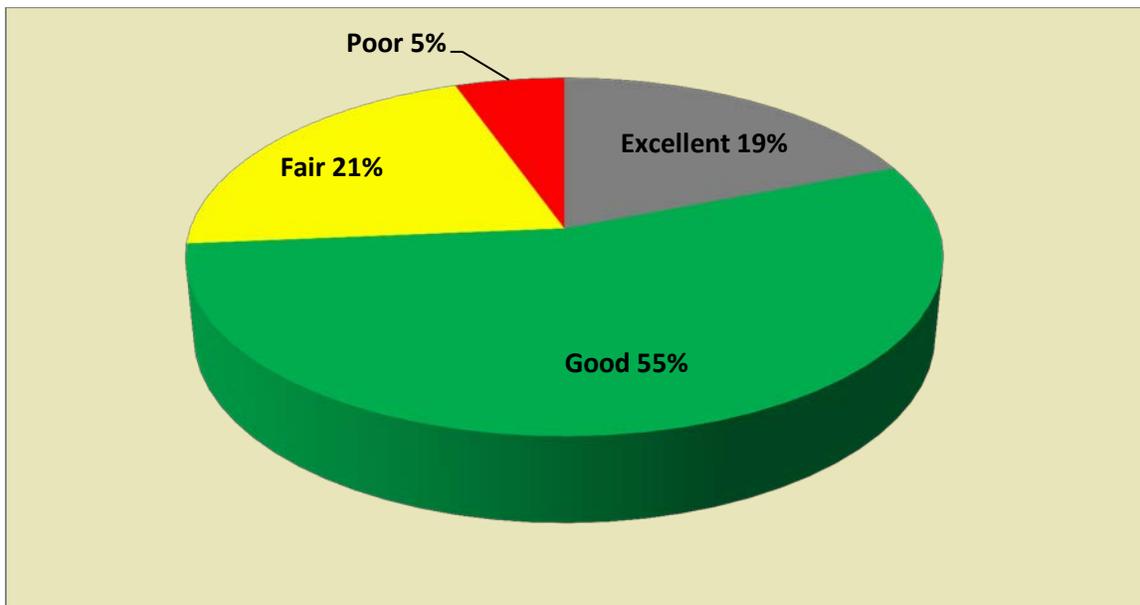
Chart 5

2015 Town of Horseheads Road Surface Conditions

The Town of Horseheads conditions were as follows: 12 miles or 19% excellent, 34 miles or 55% good, 13 or 21% fair and 3 miles or 6% poor.

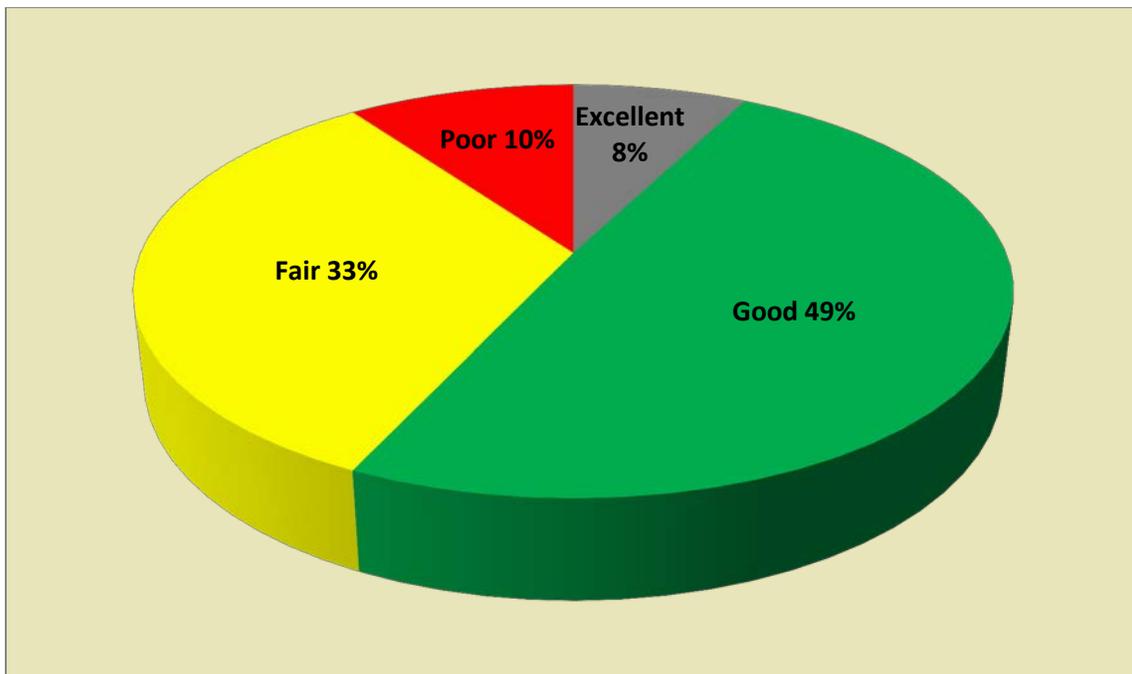
Chart 6

2015 Village of Horseheads Road Surface Conditions

The Village of Horseheads conditions were as follows: 2 miles or 8% excellent, 16 miles or 49% good, 11 or 33% fair and 3 miles or 10% poor.
