PAVEMENT CONDITION RATINGS

FOR THE NON-STATE
FEDERAL-AID ELIGIBLE
HIGHWAY SYSTEM
IN CHEMUNG COUNTY, NY

ELMIRA-CHEMUNG
TRANSPORTATION COUNCIL

2015

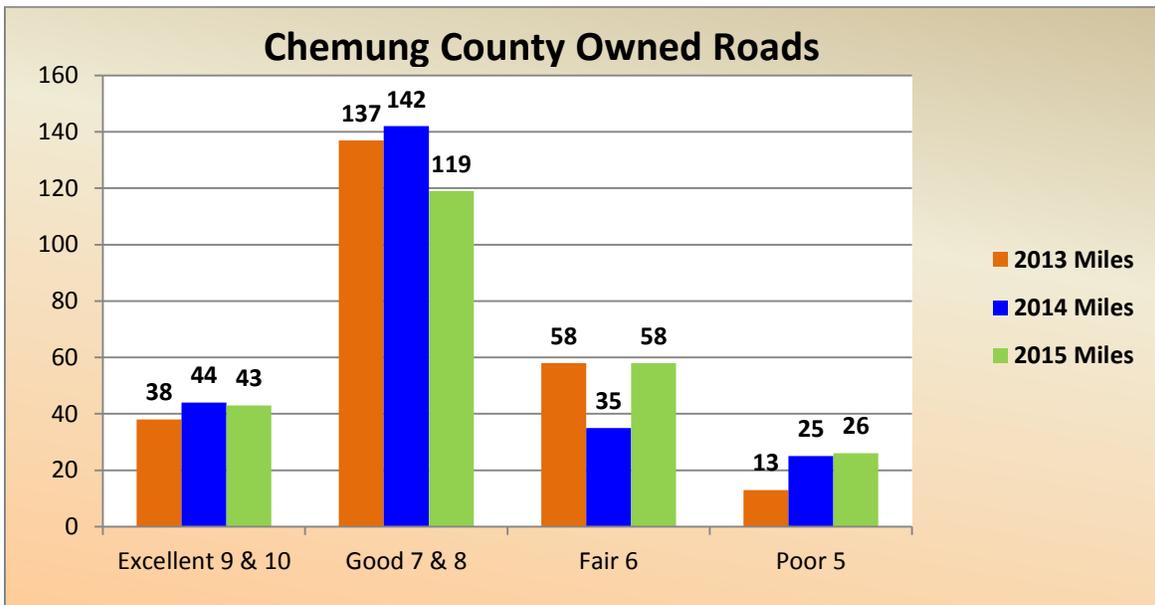
Chart 7 provides a comparison all 246 miles of all Chemung County owned roads from 2013 through 2015. In 2013 there were 38 miles of roads which received an 'Excellent' rating. This number increased 3%, or 6 miles to 44 miles from 2013 to 2014. From 2014 to 2015 that rating dropped less than 1% from 44 miles to 43 miles, a 1 mile change. The number of roads rated as 'Good' in 2013 was 137 miles. The number increased in 2014 by 2% or 5 miles to 142 miles and decreased in 2015 by 9% or 23 miles to 119 total miles. The number of roads rated as 'Fair' was 58 miles in 2013 and decreased in 2014 by 10% to 35 miles. The amount miles rated as Fair rose again in 2015 by 10% to 58 miles. The number of roads rated 'Poor' was 13 miles in 2013 and increased by 12 miles in 2014 or 5% to 25 total miles and increased by 1 mile or less than 1% to 26 miles in 2015.

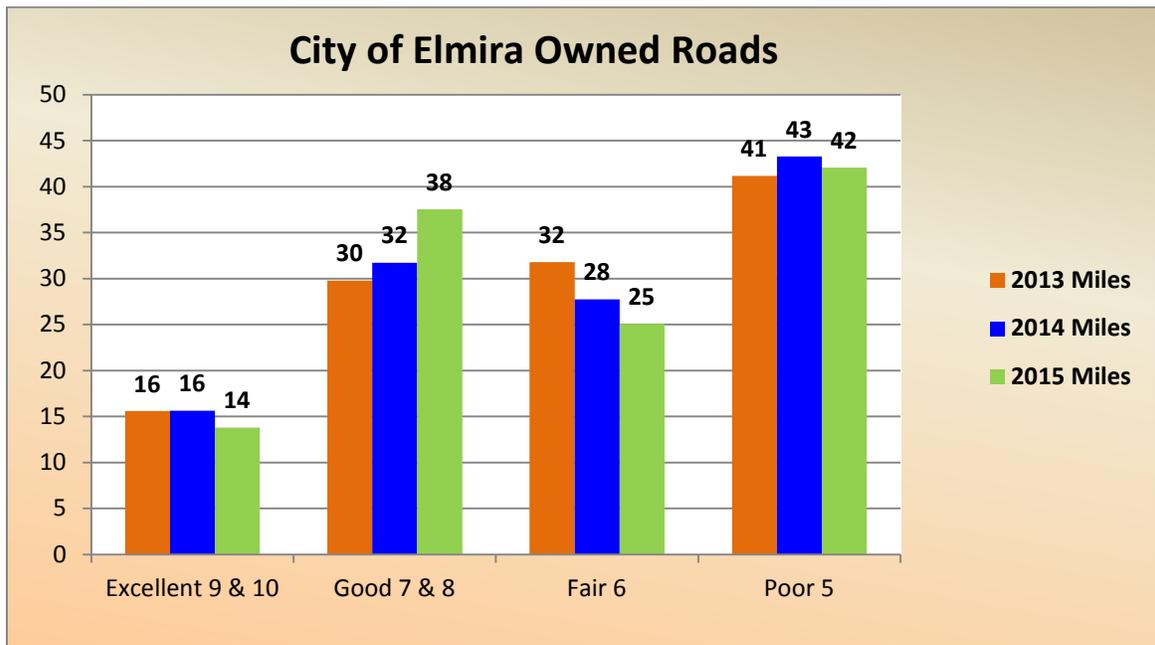
Chart 8 provides a comparison all 118 miles of City owned roads from 2013 through 2015. In 2013 there were 14 miles of roads which received an 'Excellent' rating. This number increased 4%, or 5 miles to 19 miles from 2013 to 2014 and an additional 1 mile from 2014 to 2015 to 20 total miles. The number of roads rated as 'Good' in 2013 was 92 miles. The number of good miles decreased in 2014 by 4% or 5 miles to 87 miles and decreased again in 2015 by 5% or 8 miles to 79 miles. The number of roads rated as 'Fair' was 28 miles in 2013 and stayed at the level through 2014 and increased 6%, up 8 miles from 2014 to 2015. The number of roads rated 'Poor' was 8 miles in 2013 and 2014 and decreased 1% to 6 miles in 2015.

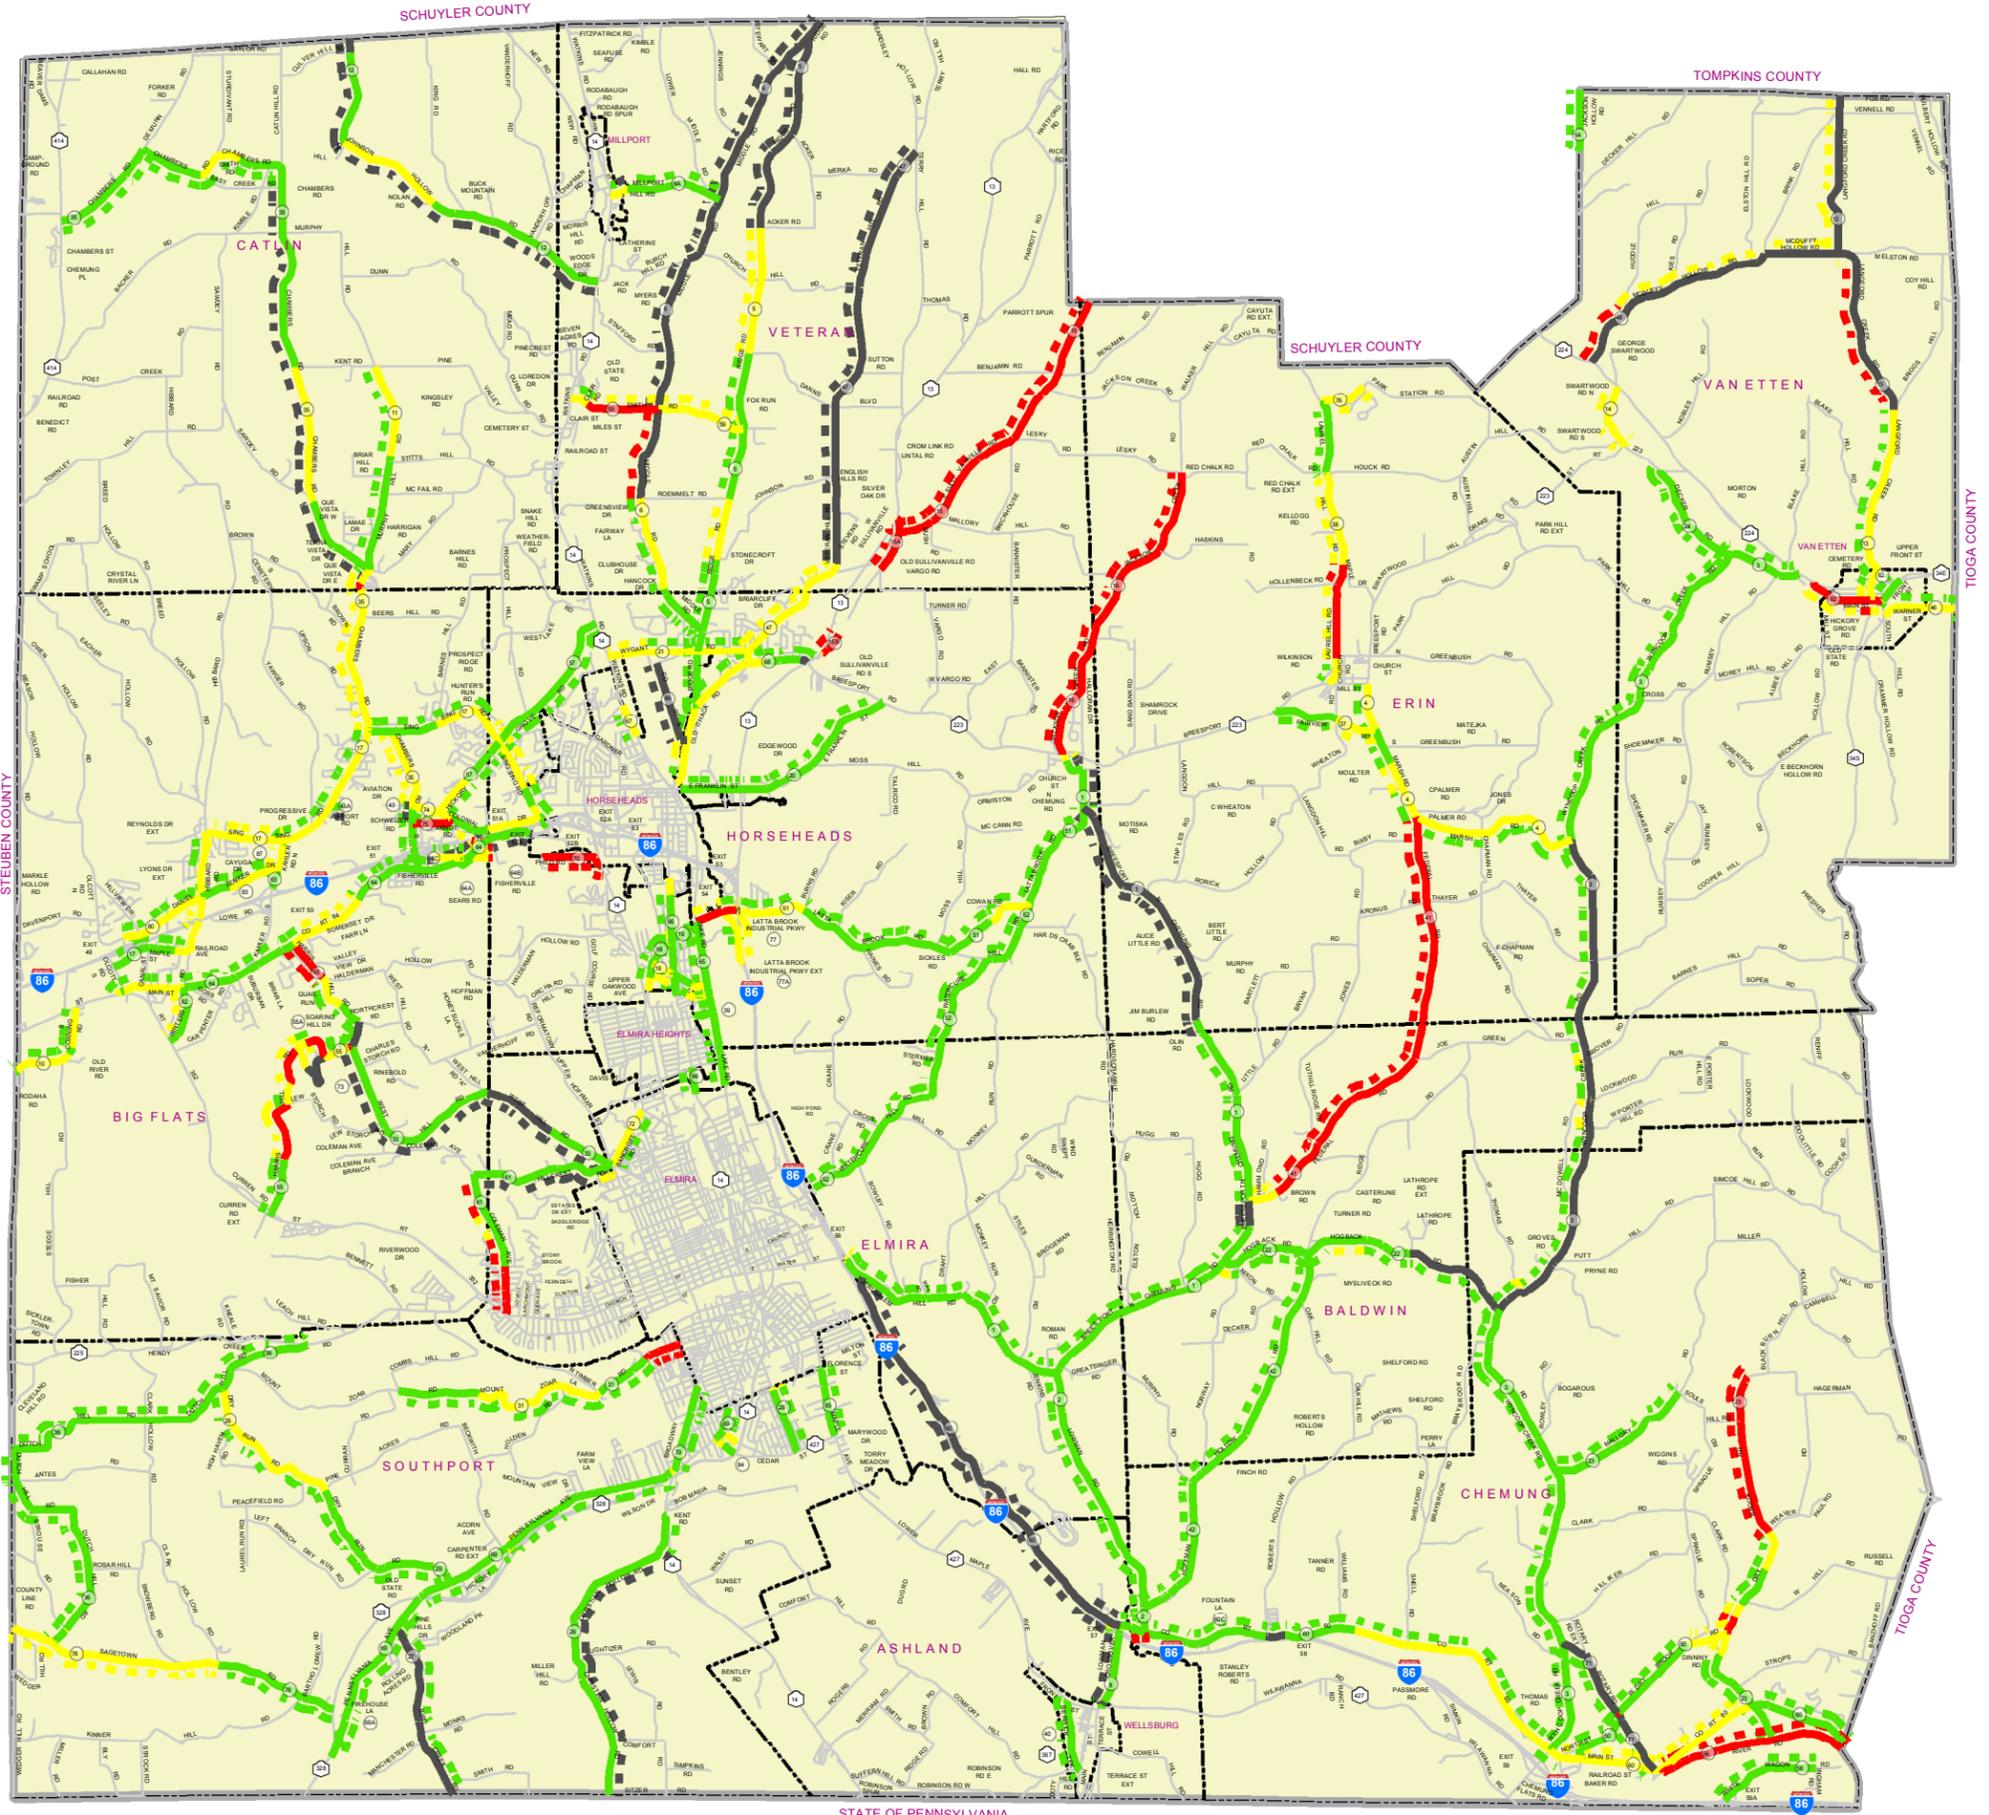
2014 & 2015 PAVEMENT CONDITIONS for CHEMUNG COUNTY

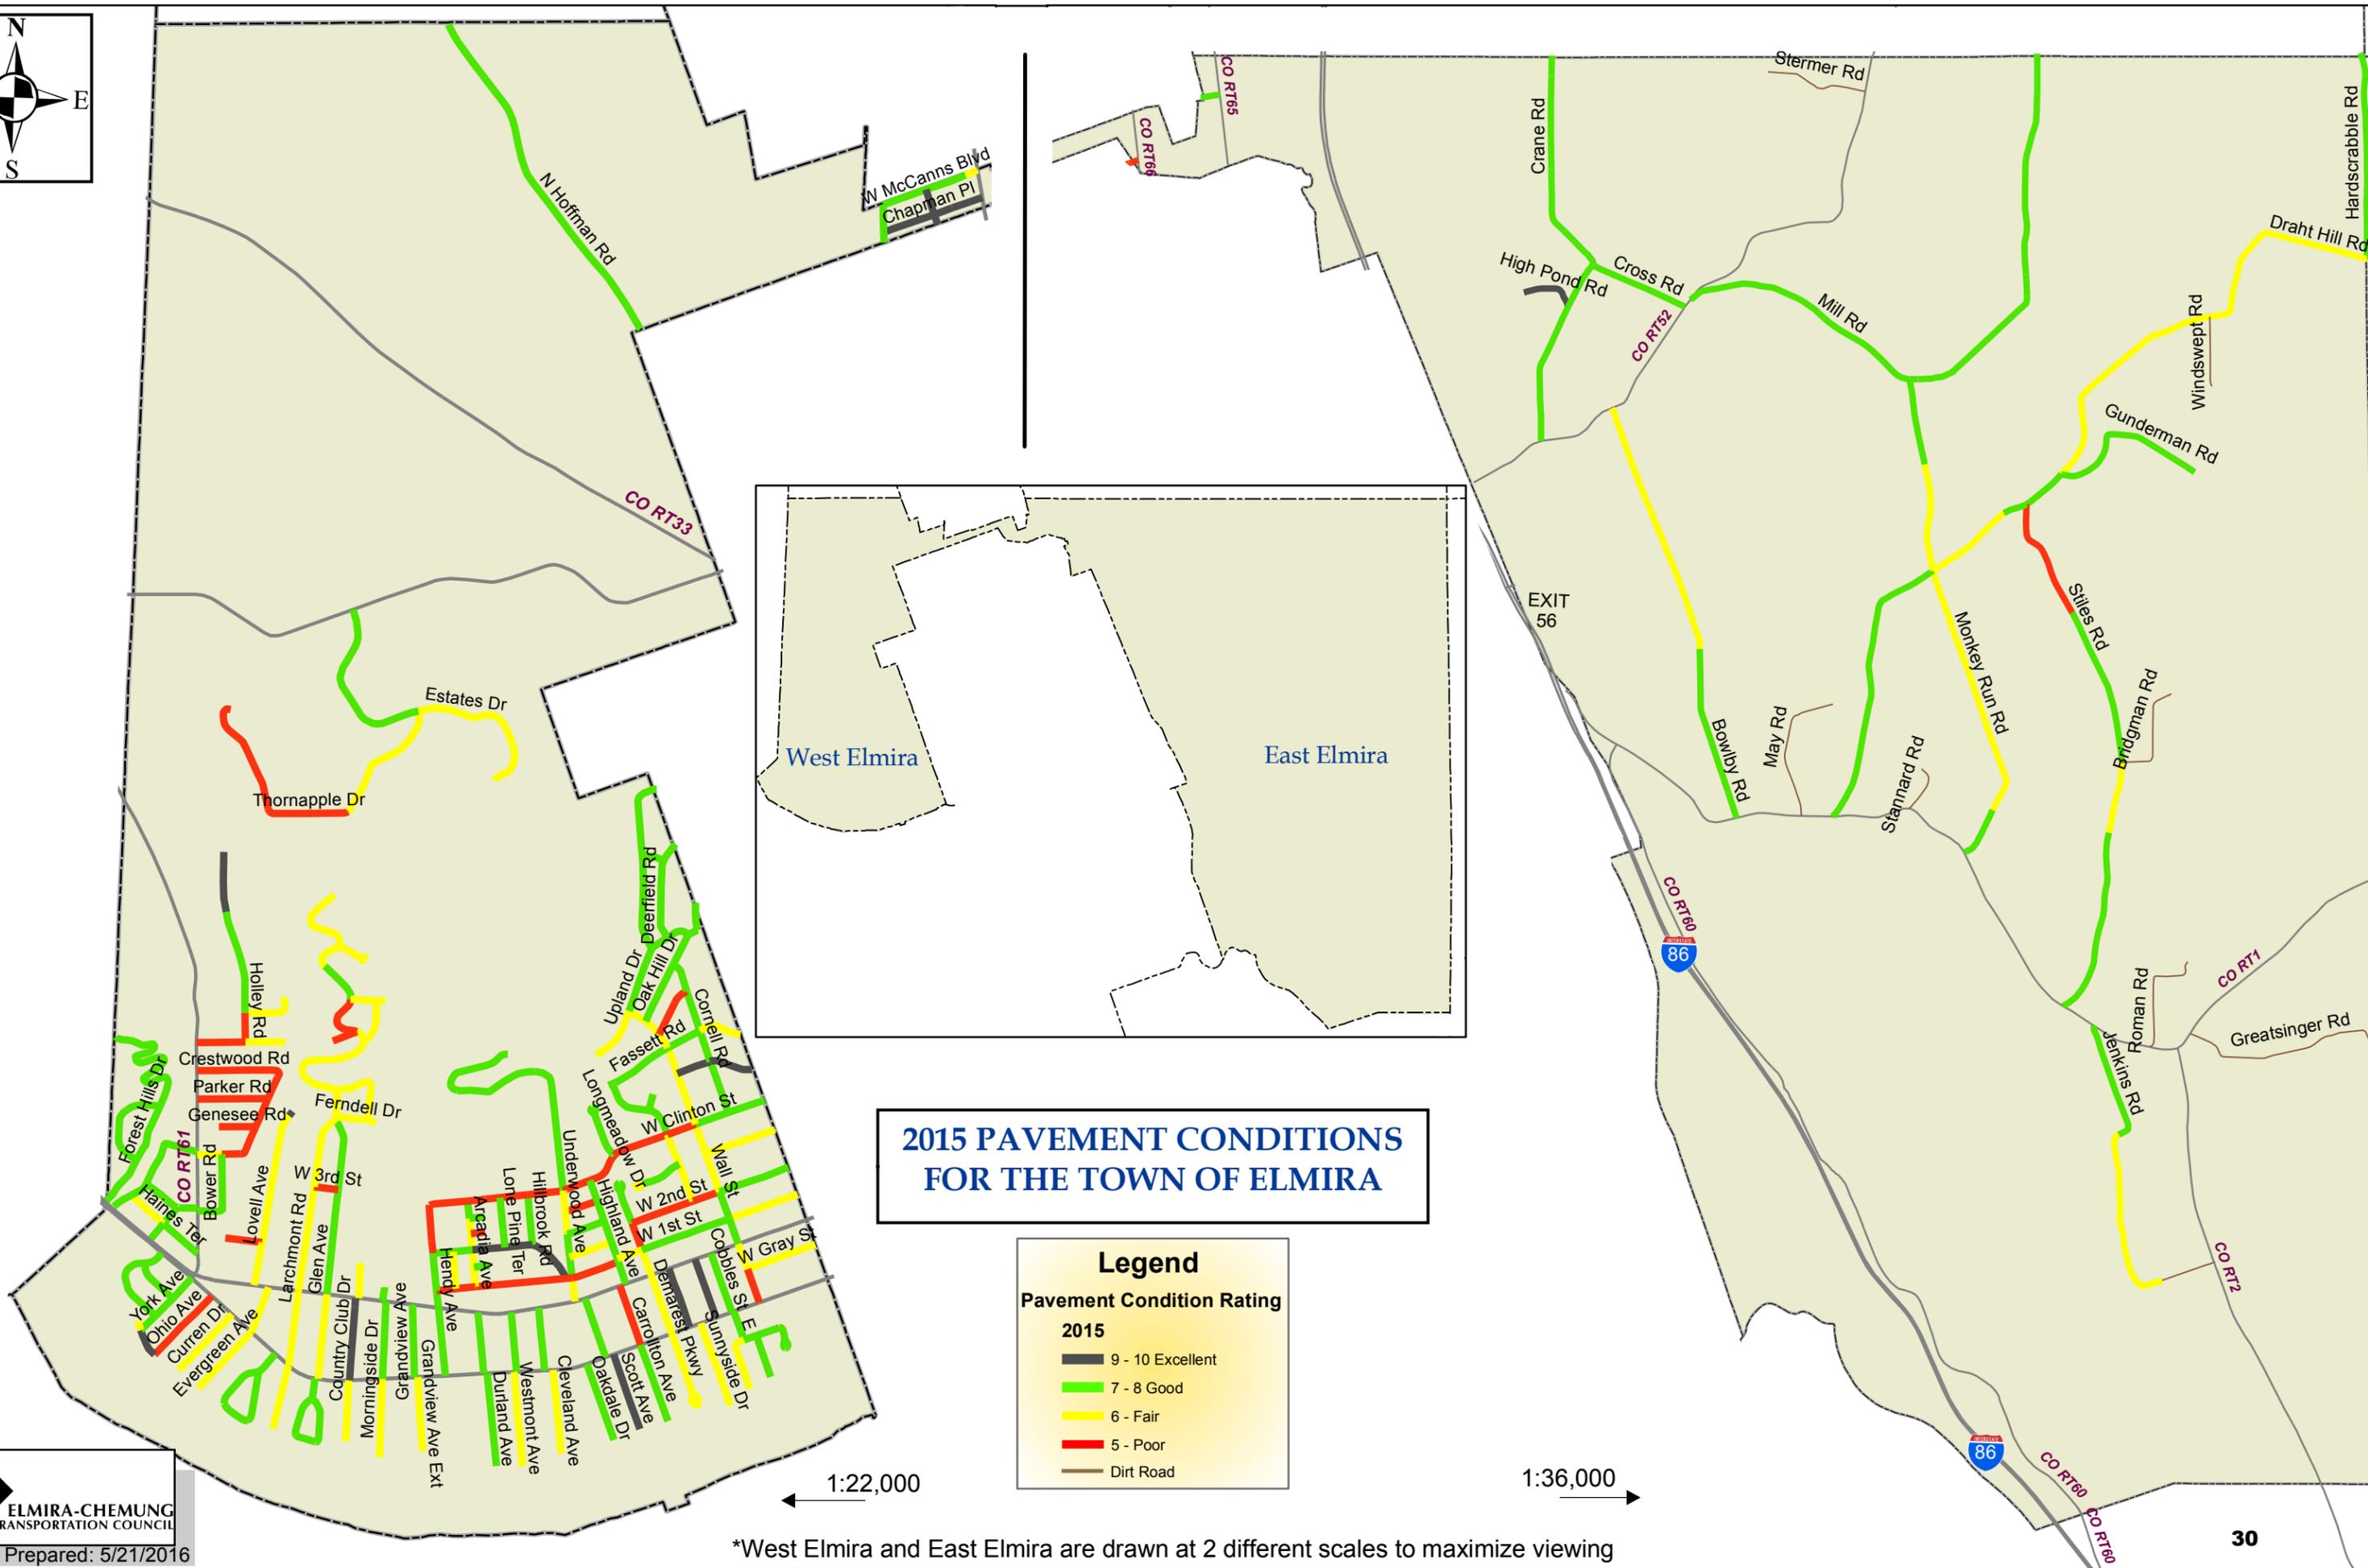
2015 PAVEMENT CONDITIONS FOR THE TOWN OF ELMIRA

*West Elmira and East Elmira are drawn at 2 different scales to maximize viewing

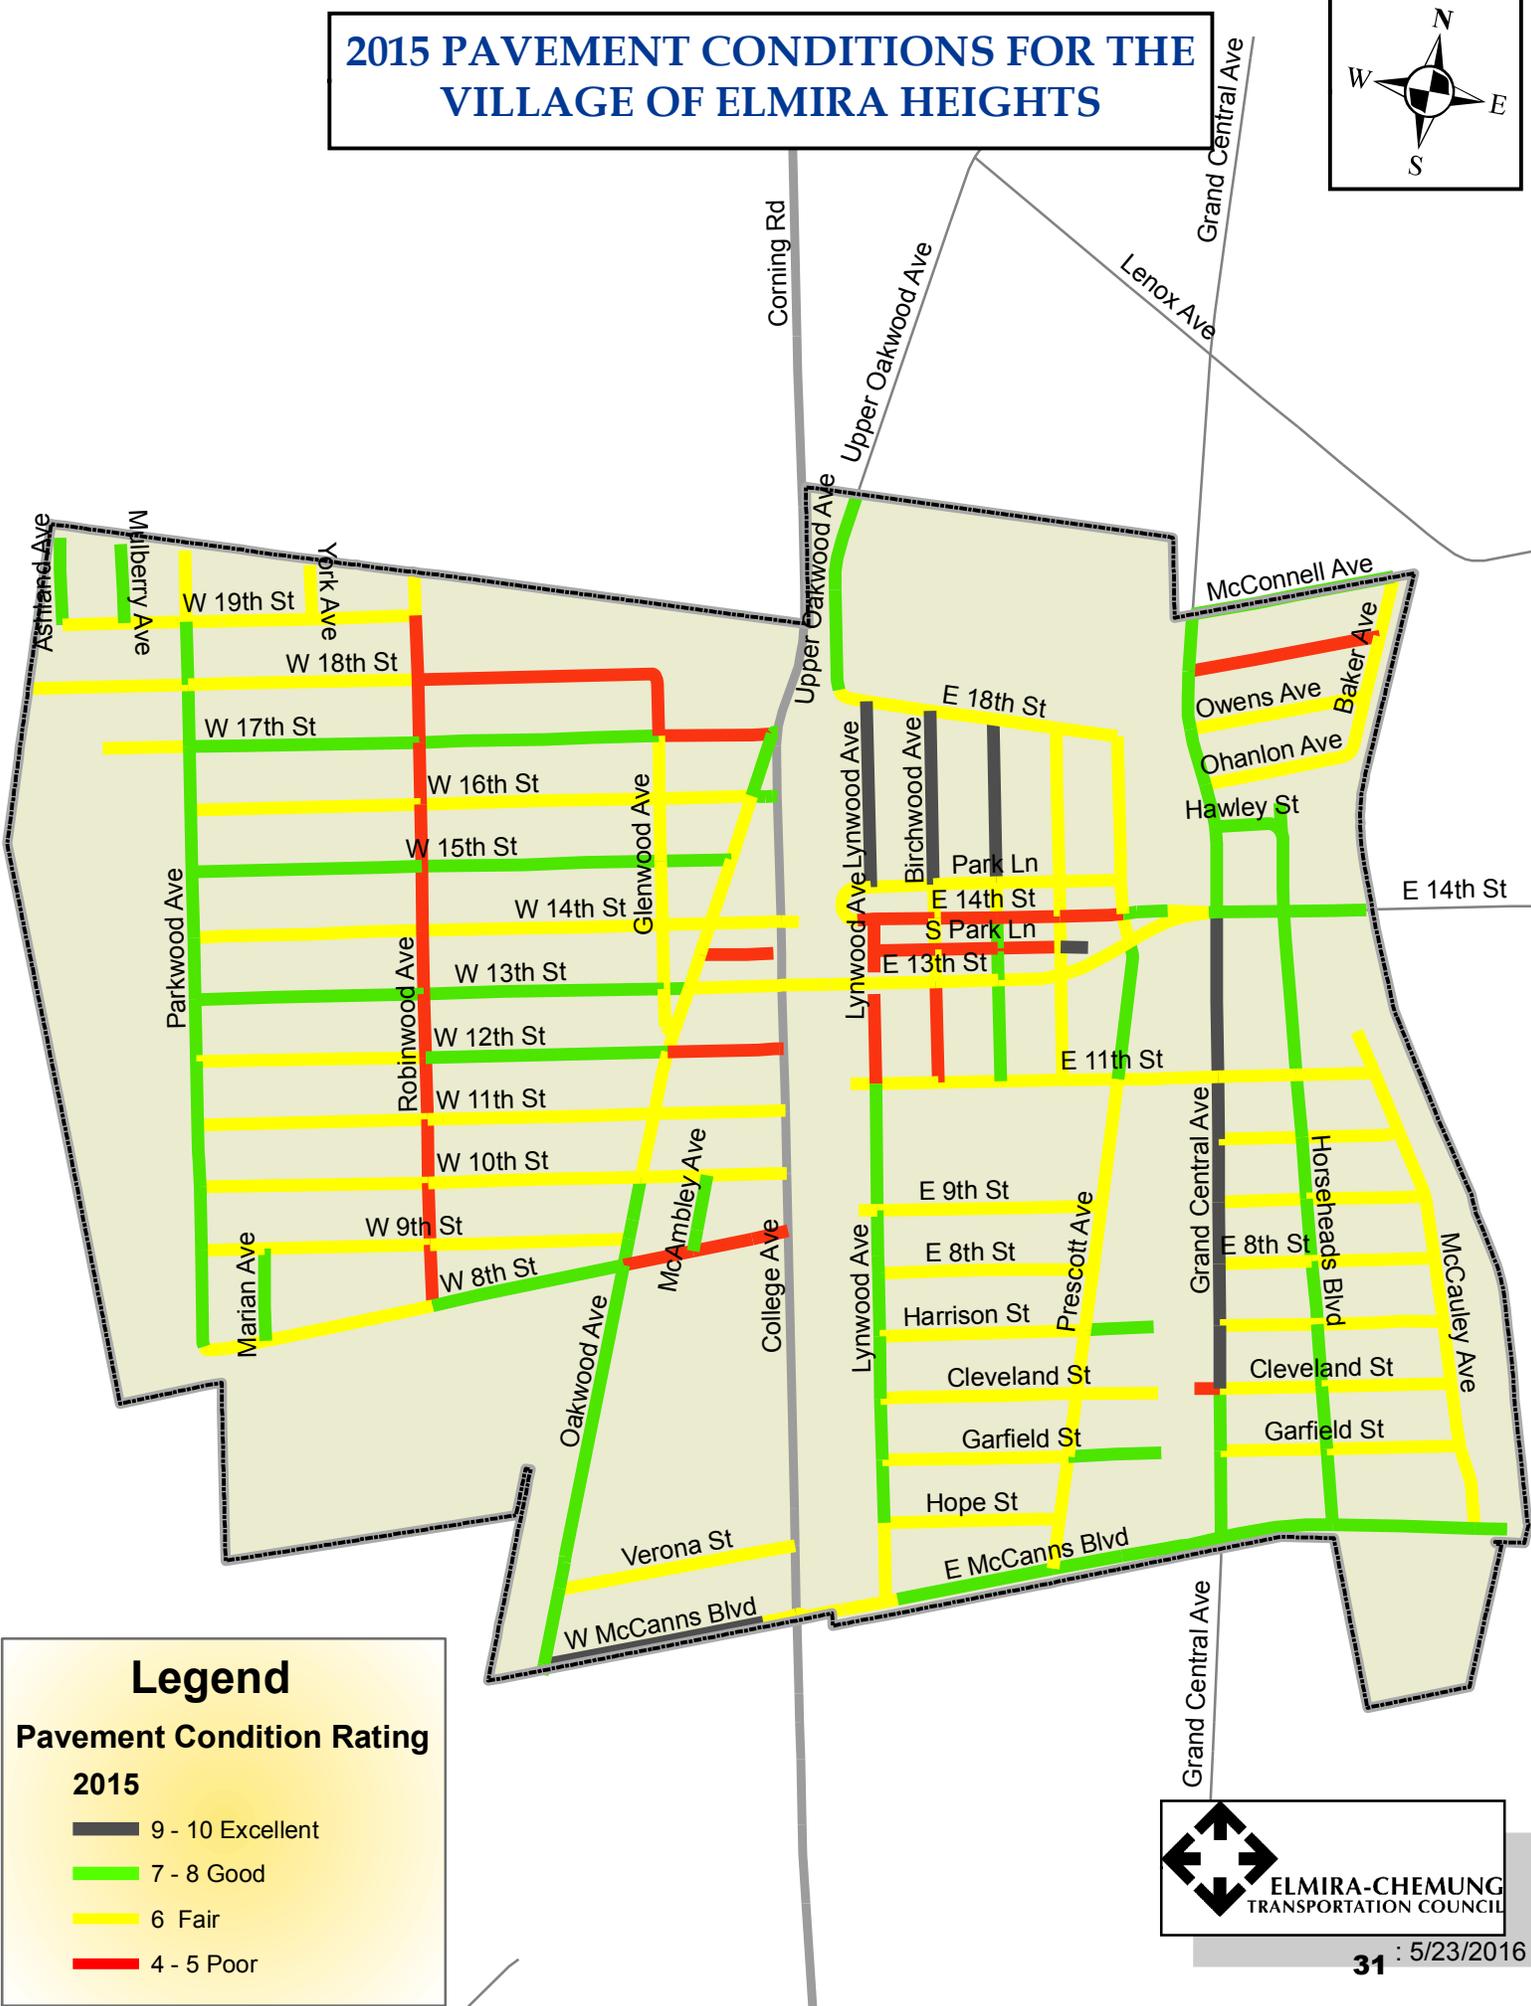
2015 PAVEMENT CONDITIONS FOR THE VILLAGE OF ELMIRA HEIGHTS

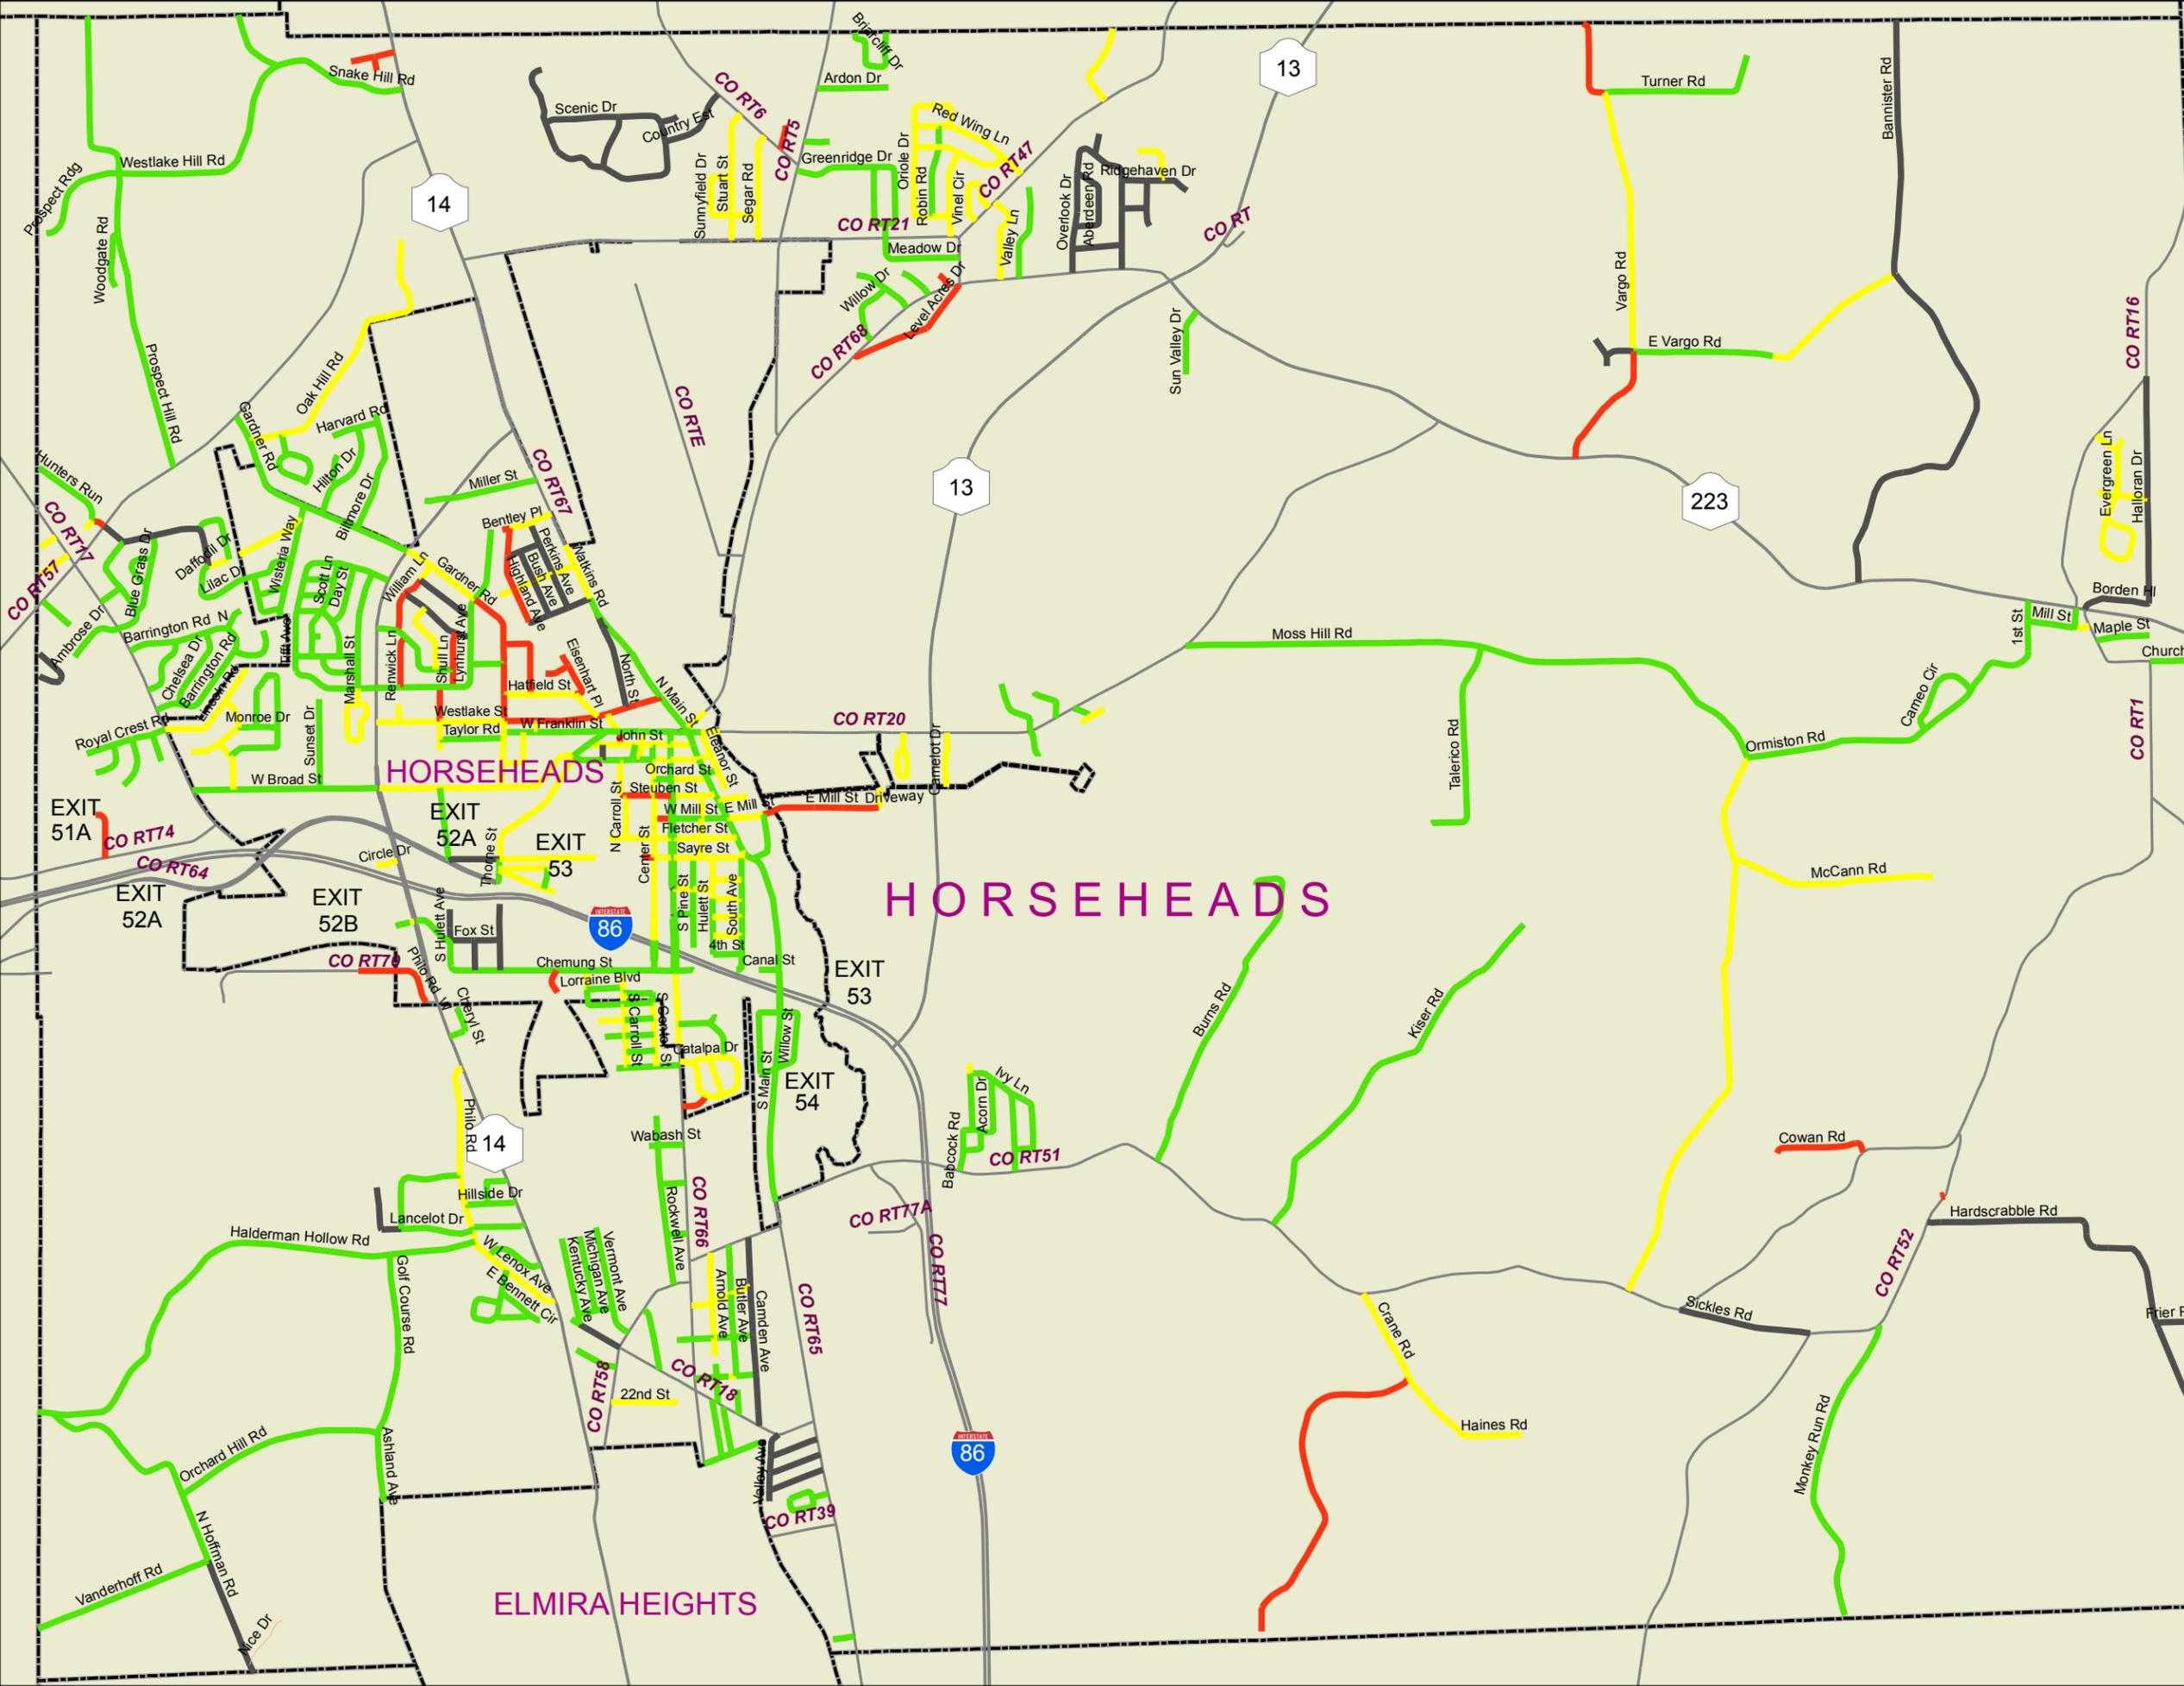
2015 PAVEMENT CONDITIONS FOR THE TOWN AND VILLAGE OF HORSEHEADS
